DEPARTMENT OF THE NAVY  
MILITARY SEALIFT COMMAND  
471 EAST C STREET  
NORFOLK VA 23511-2419

FINAL ENDORSEMENT on CAPT (b)(6) ltr 5800 of 20 Nov 24

Subj: COMMAND INVESTIGATION INTO THE FACTS AND CIRCUMSTANCES  
SURROUNDING THE GROUNDING OF USNS BIG HORN (T-AO 198) OFF THE  
COAST OF OMAN ON 23 SEPTEMBER

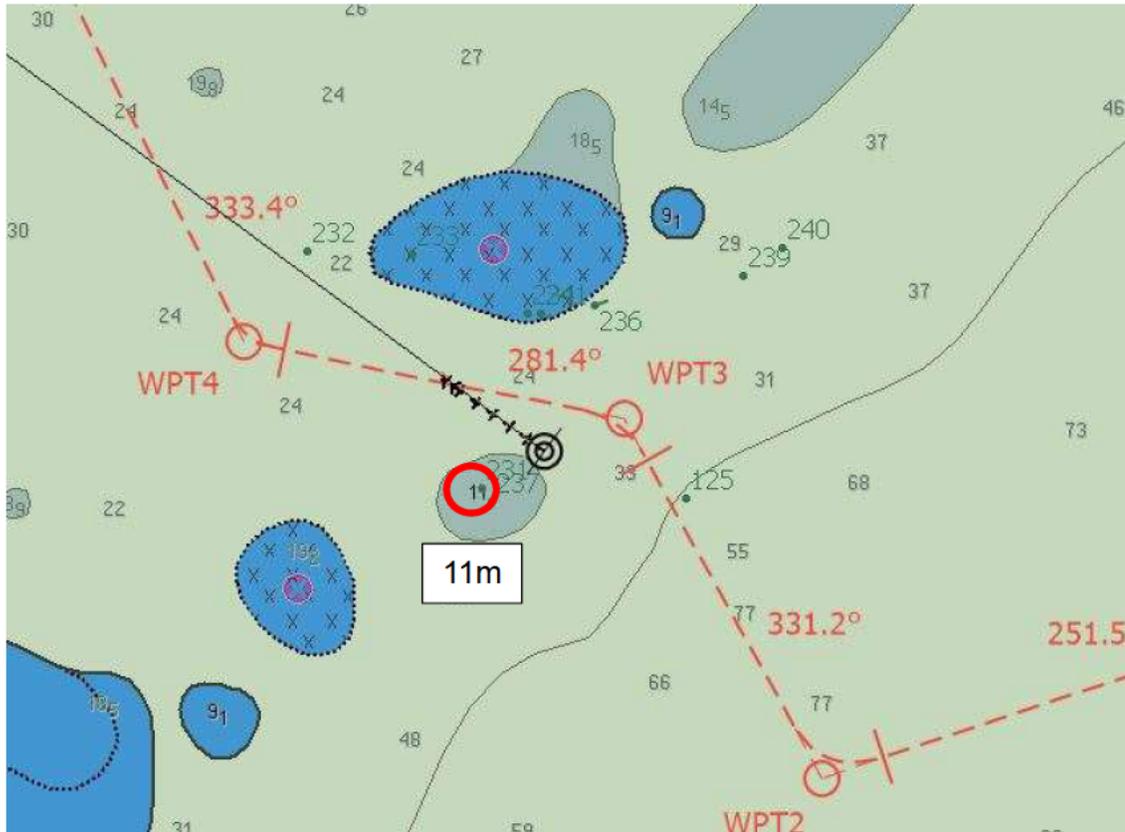
165. At 1404L, BGN was 1,600yds from the 11m sounding to south and 560yds from the 20m contour (not full contour due to Captain's range scale) containing the 11m sounding. See Figure 10. [Encl 41, 42, 43]

Figure 10 - ECDIS 5 screen capture of CPA distance from track to 20m contour. This is the Captain's view. Green numbers (ie 232) with dots represent surface contacts from radar.

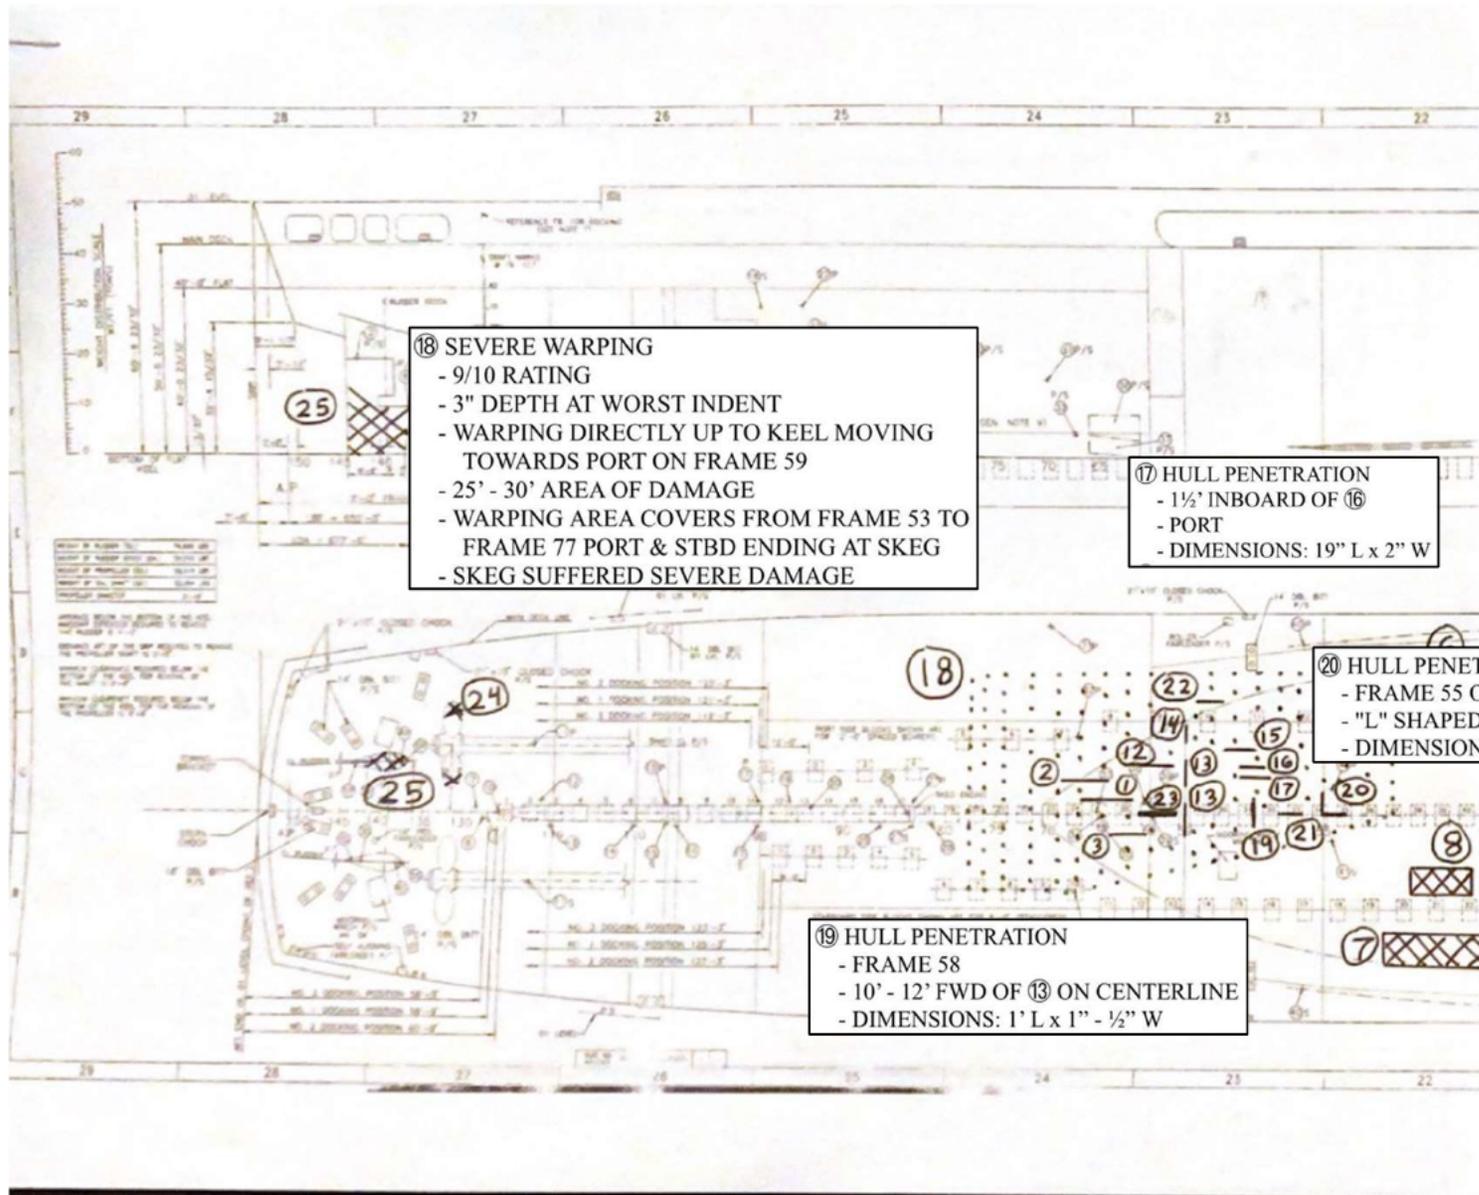
18 SEVERE WARPING  
 - 9/10 RATING  
 - 3" DEPTH AT WORST INDENT  
 - WARPING DIRECTLY UP TO KEEL MOVING TOWARDS PORT ON FRAME 59  
 - 25' - 30' AREA OF DAMAGE  
 - WARPING AREA COVERS FROM FRAME 53 TO FRAME 77 PORT & STBD ENDING AT SKEG  
 - SKEG SUFFERED SEVERE DAMAGE

17 HULL PENETRATION  
 - 1½' INBOARD OF 16  
 - PORT  
 - DIMENSIONS: 19" L x 2" W

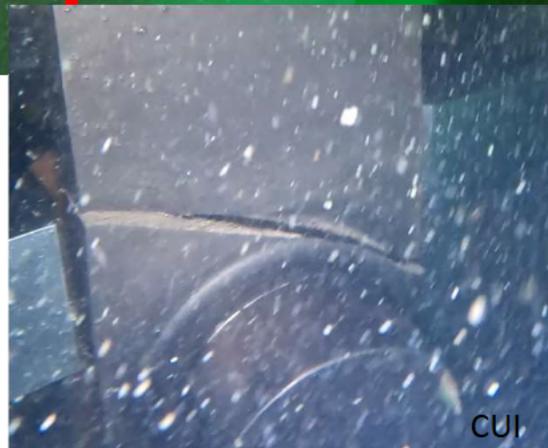
Crack in block assembly

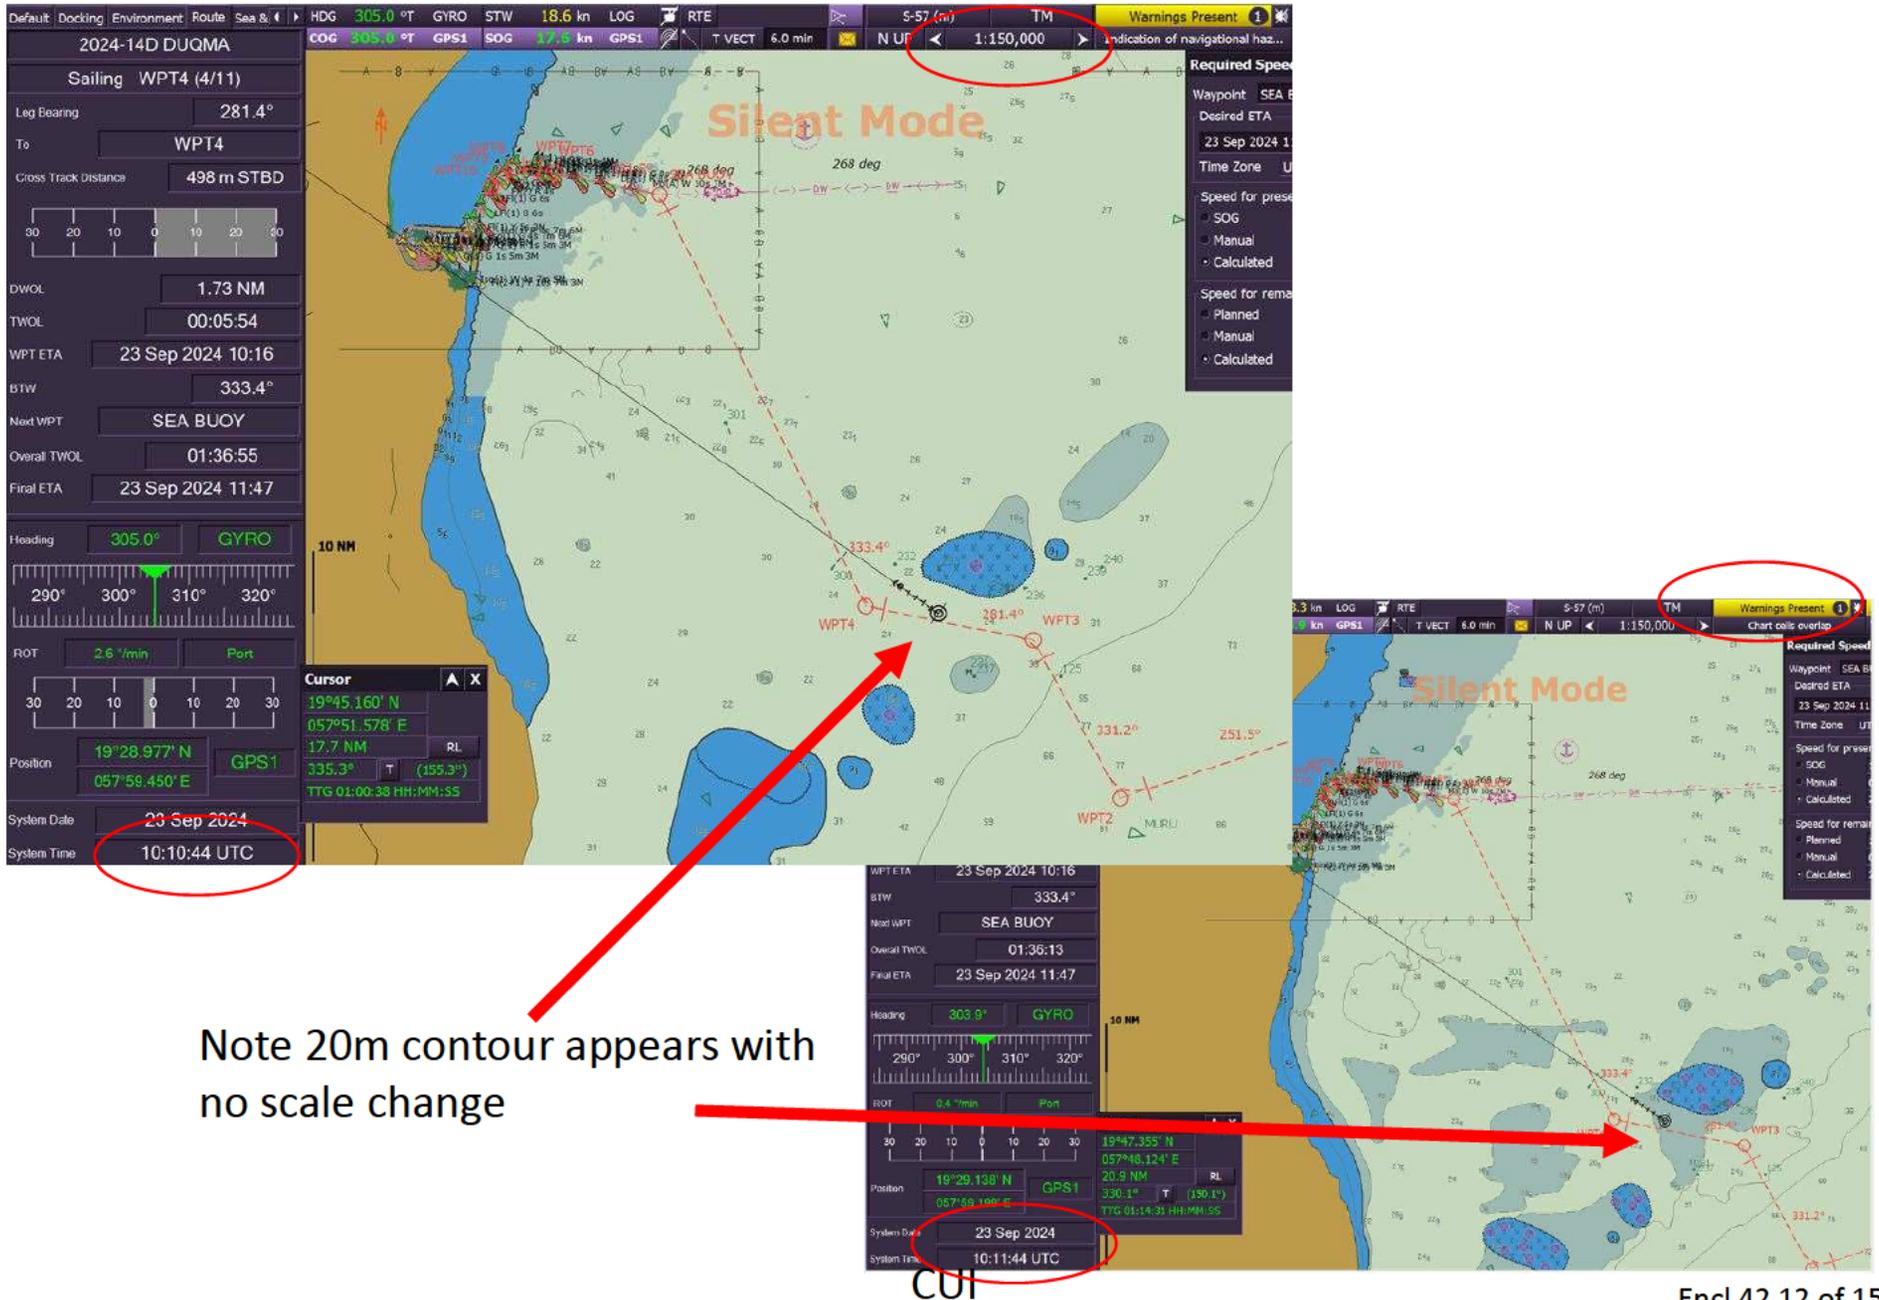
# ECDIS 5 Chart Shift at 14:11:44

Note 20m contour appears with no scale change

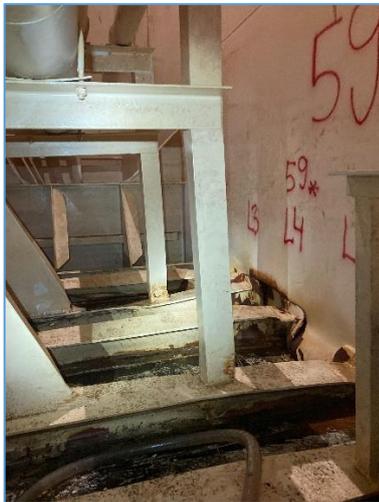
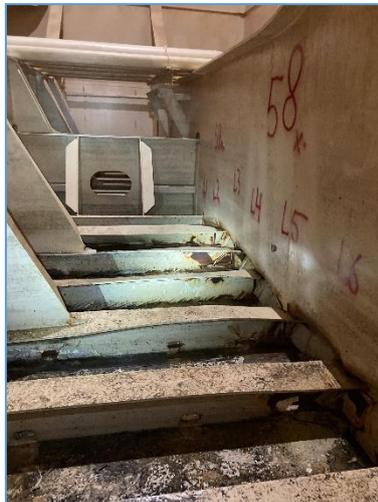
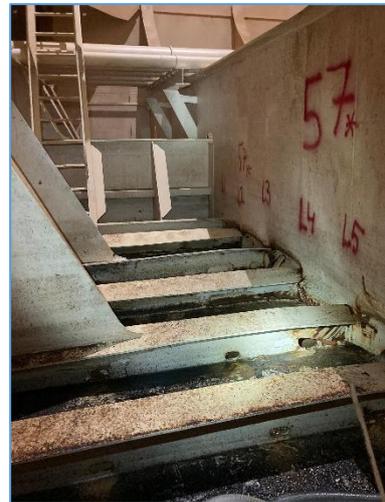
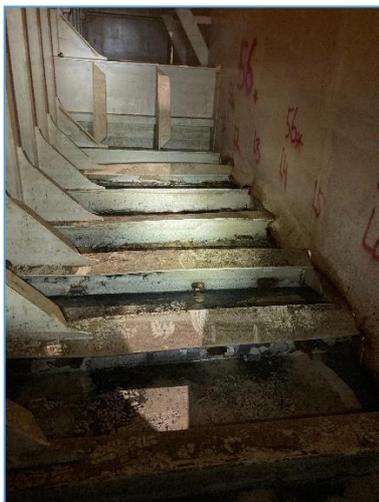
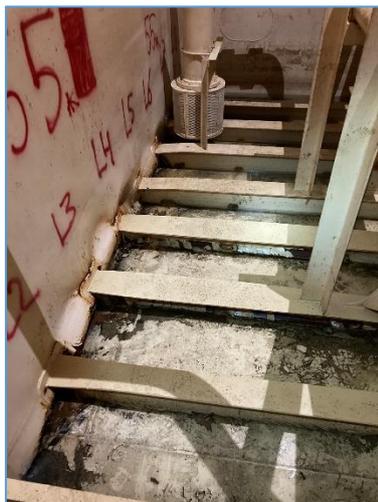
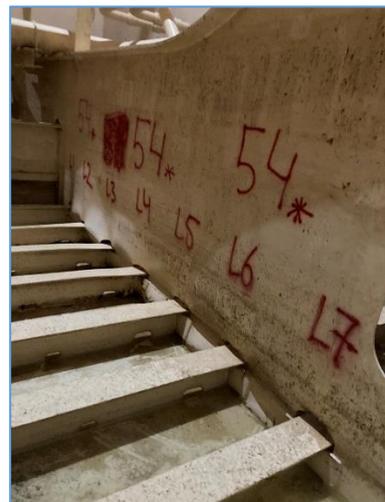
Typical damage in Cargo Tank 9C and Cargo Tank 10C is depicted in below figures. For these tanks the main damaged area is on PS between Longitudinal 2 and Longitudinal 7 where Cargo Tank 10C has more damage compared to Cargo Tank 9C.

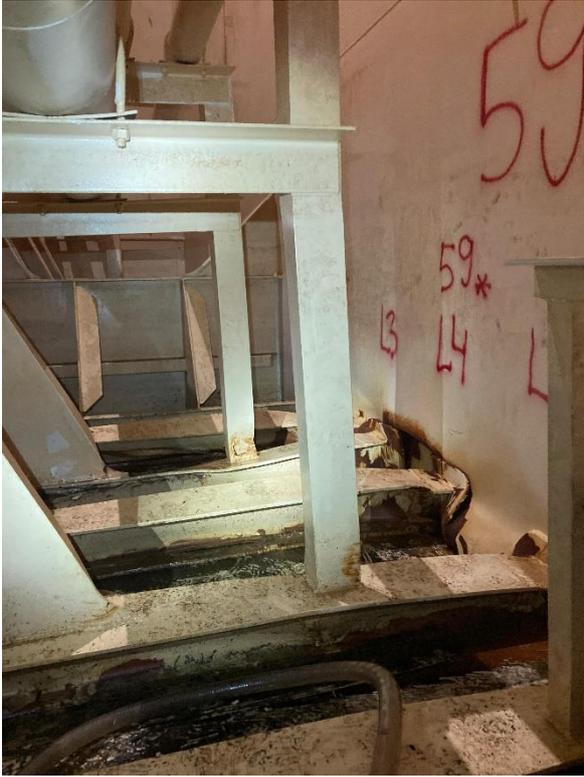
Figure 1 - PS CT 10C Frame 59 looking aft

Typical damage in Cargo Tank 9C and Cargo Tank 10C is depicted in below figures. For these tanks the main damaged area is on PS between Longitudinal 2 and Longitudinal 7 where Cargo Tank 10C has more damage compared to Cargo Tank 9C.

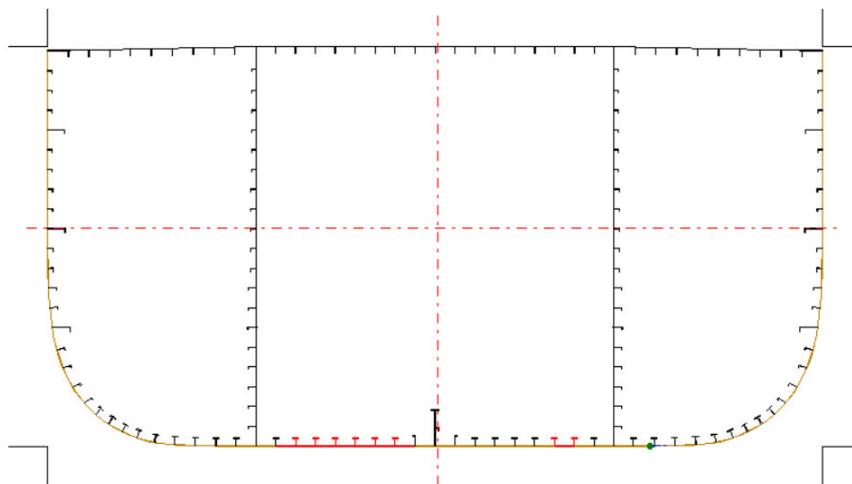
Figure 11 - Frame 55 Cross Section Looking Fwd with Damage and Corrosion

Below figure indicates the damaged structural members in red and the corroded Shell/Bottom plating in orange at frame 55.

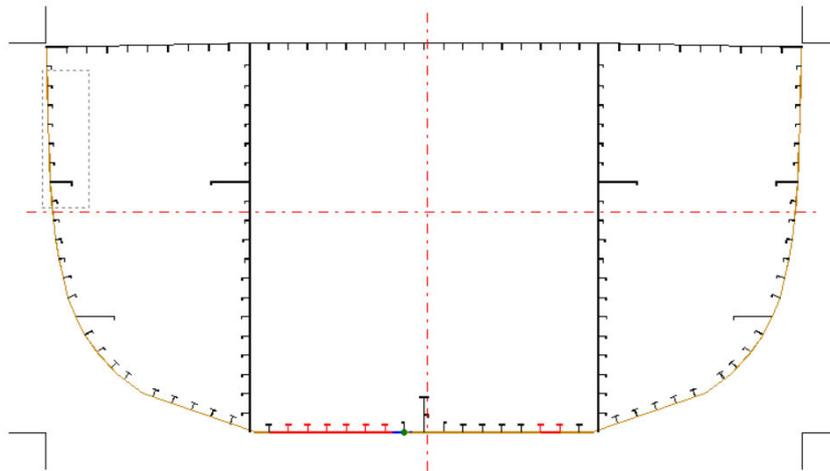
Figure 13 - Frame 59 Cross Section Looking Fwd with Damage and Corrosion

Below figure indicates the damaged structural members in red and the corroded Shell/Bottom plating in orange at frame 59.

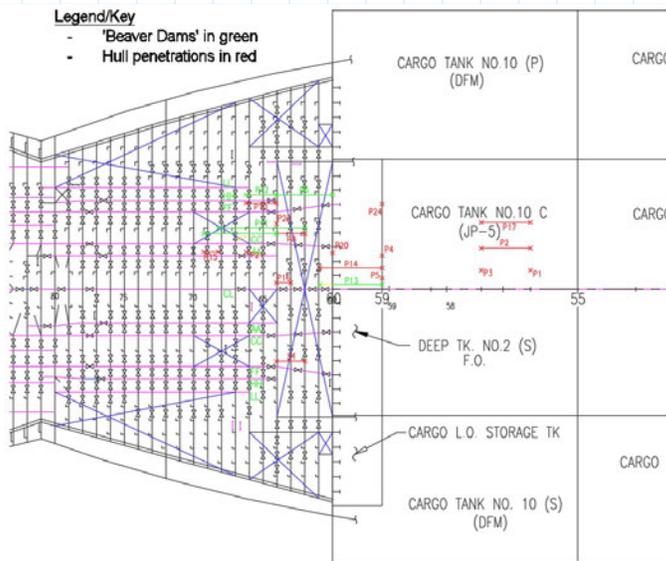
The approximated diver indicated location of the 'Beaver Dams' and hull penetrations is plotted:

Safe tank access of all breached tanks was established through discharging, stripping and ventilating the breached tanks. This requires daily tank monitoring, involving gas measurements to ensure safe access, followed by the appropriate use of Personal Protective Equipment (PPE). With safe breached tank access the damage could be examined from the inside. It should be noted that only the 'Beaver Dams' could be identified from the inside of the ship through visual inspection of the wooden wedges as there is no way of identifying smaller hull penetrations where only the type of epoxy was applied from the outside.

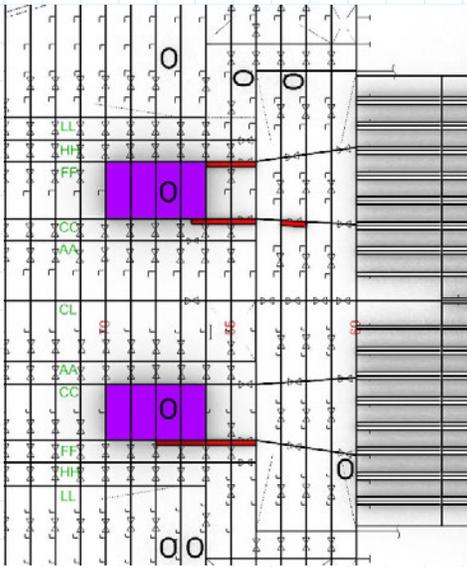
All diver stated 'Beaver Dams' have been identified except for one. Divers' measurements locate this 'Beaver Dam' inside Deep Tank 2P. A reason for not able to locate this 'Beaver Dam' could be that the steel deformation of hull plating and longitudinal stiffeners inside Deep Tank 2P to such extent that the 'Beaver Dam' is underneath the deformed steel and cannot be identified from the inside. The identified 'Beaver Dams' from the inside are plotted in red in the figure below.

Based on observed deformations and hull penetrations, a grout plan was developed to internally seal the hull penetrations. This plan incorporates compartmentalization to facilitate grout application and ensure adequate pour height in each section.
