DEPARTMENT OF THE NAVY  
MILITARY SEALIFT COMMAND  
471 EAST C STREET  
NORFOLK VA 23511-2419

FINAL ENDORSEMENT on CAPT (b)(6) ltr 5800 of 20 Nov 24

Subj: COMMAND INVESTIGATION INTO THE FACTS AND CIRCUMSTANCES  
SURROUNDING THE GROUNDING OF USNS BIG HORN (T-AO 198) OFF THE  
COAST OF OMAN ON 23 SEPTEMBER

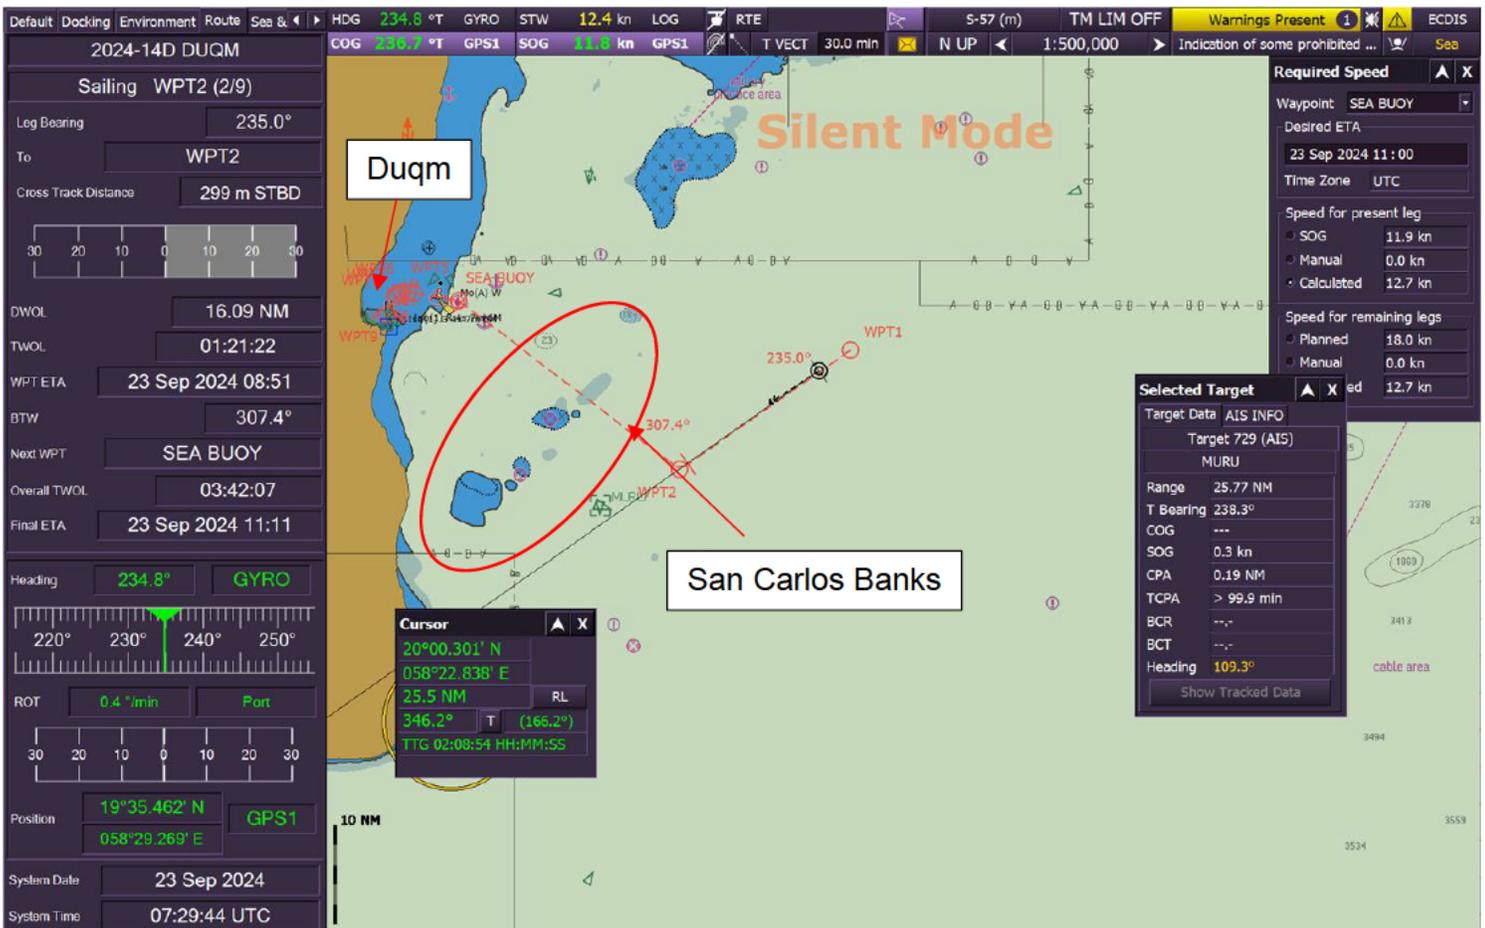
79. The ECDIS safety contour, defined as the line on a chart that indicates the boundary between safe and unsafe water for a vessel, was set to 10m. [Encl 14, 42]
80. The ECDIS deep contour was set to 20m. [Encl 42]
81. The ECDIS draft and maximum draft were both set to 9m. [Encl 42]
82. Restated from FF #57: NAV brief and entering port checklist for Duqm on 23SEP24 stated BGN draft FWD 8.23m, MID 9.12m, and AFT 9.93m. [Encl 15, 16]
83. Both ECDIS 4 and 5 were in “silent mode” and alarms were not audible, but visual alarm queue was present. [Encl 41, 42, 43]

Figure 1 – ECDIS 5 Screen Capture at OKN RAS Start, approx. 11:30L.

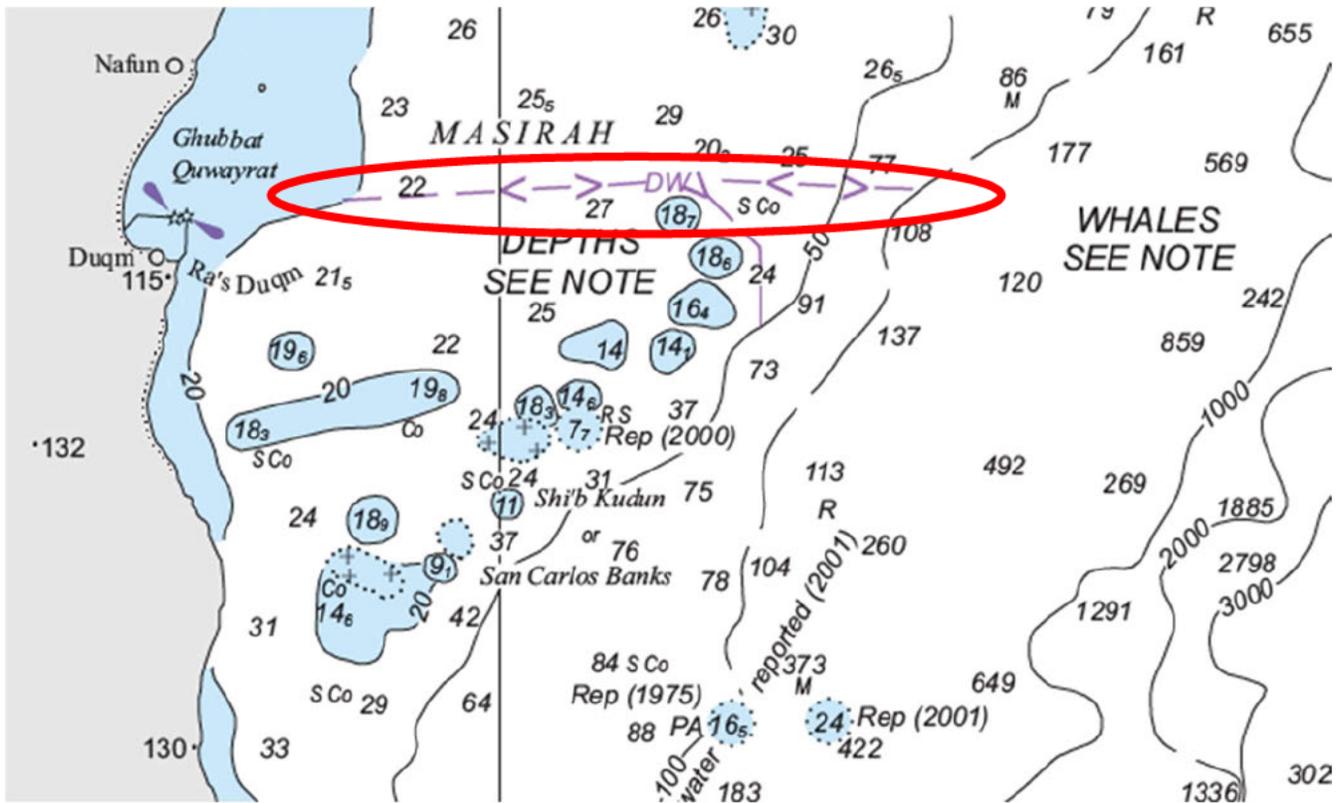
Figure 2 - Screen Capture of NGA Chart 62024 – Note deep water “DW” route in purple

86. At 1203, VDR recorded conversation between Navigator and 3/O (b)(6) regarding navigation track and use of the deep water route.

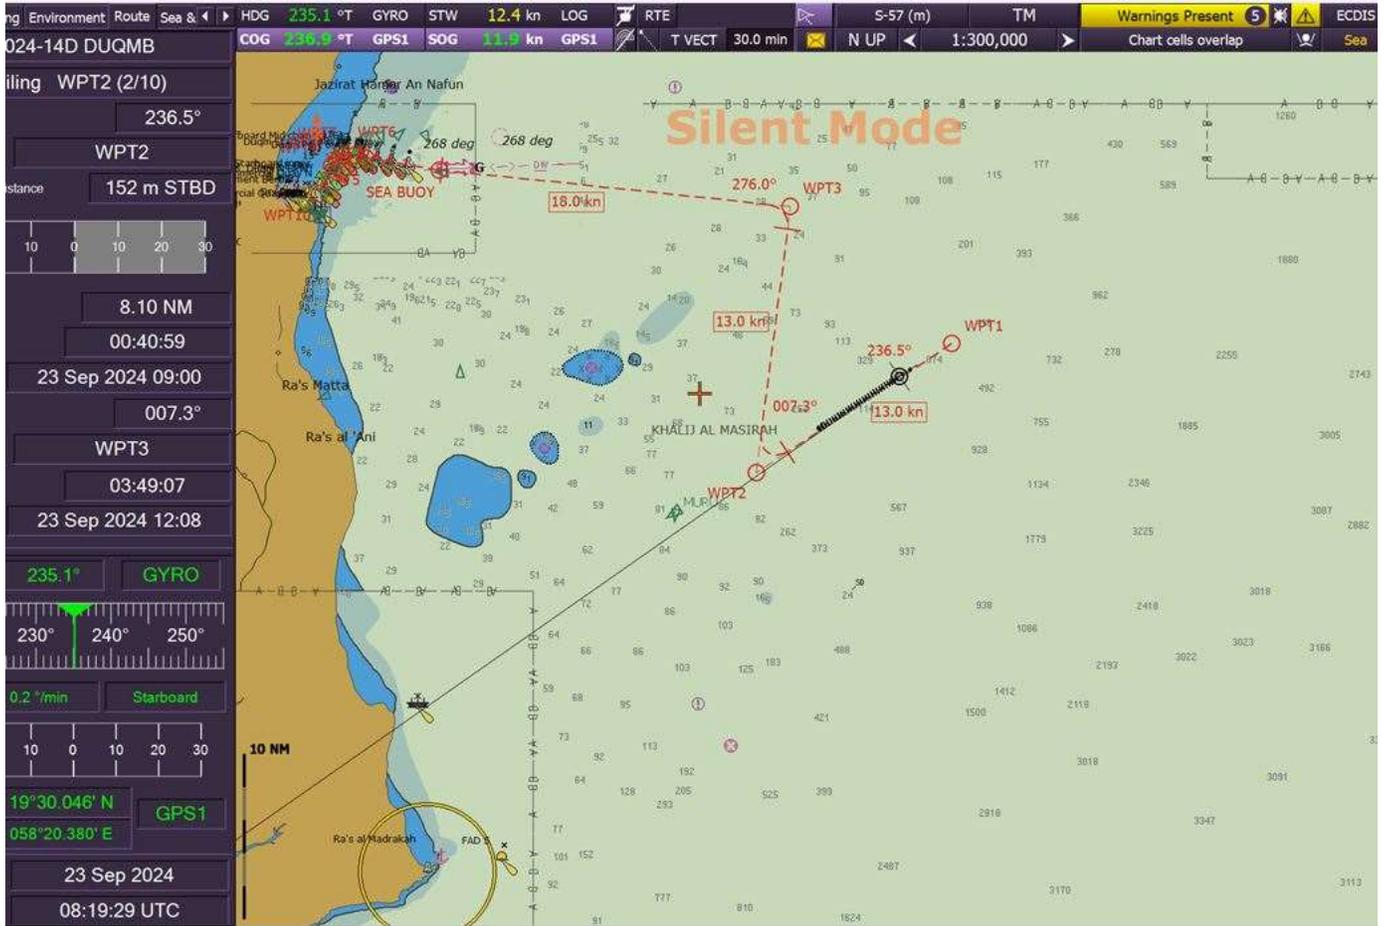
87. At 12:19, Chief Mate takes the comm. [Encl 20, 41, 43]
88. Two track options began to emerge from the 1203 conversation, referred to a "Duqm A" and "Duqm B." Duqm B track left the San Carlos Banks to the west/southwest of BGN and intercepted the deep water route. This was not the track ultimately used. The Navigator refers to this on the VDR recording as (b)(6) route." See Figure 3. [Encl 2, 4, 5, 6, 41, 42, 43]

Figure 3 - "Duqm B" Track 1219L

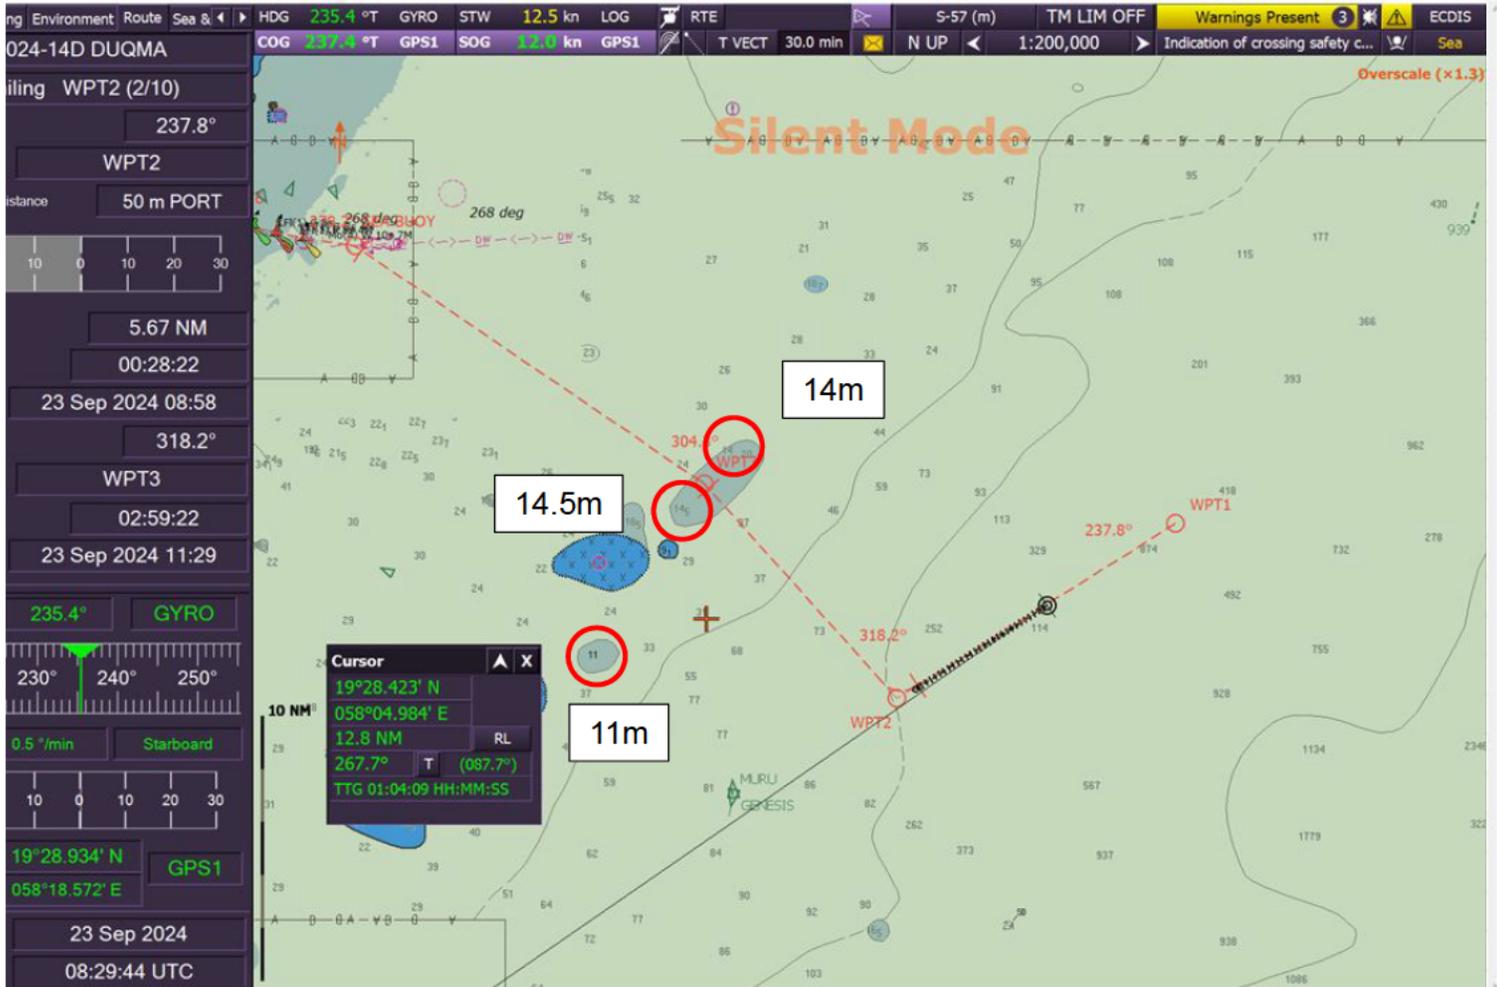
- 89. Duqm A, a more direct route, initially split the difference between two soundings, 14m and 14.5m, inside of a 20m safety contour north of the San Carlos Banks reef. This track was under continuous adjustment as the RAS progressed and continued southwest. See Figure 4.[Encl 2, 4, 5, 6, 41, 42, 43]
- 90. Duqm A, as planned to this point, crossed the 20m contour and split the middle of a 14m and 14.5m charted sounding with a CPA to shoal of approx. 2800yds and CPA to charted 14m sounding of 1800 yds. See Figure 4. [Encl 41, 42, 43]
- 91. This version of Duqm A was not ultimately used. [Ref d, Encl 41, 42, 43]
- 92. The Navigator briefed the Captain at 1226 and proposed the two tracks, Duqm A and B. [Encl 2, 4, 5, 6, 41, 42, 43]

Figure 4 - "Duqm A" Track, First Iteration, 1230L

106. The ECDIS 1:200,000 scale the Captain and Navigator used to discuss the proposed track was too small to show the 20m contour except in the immediate vicinity of the 11m sounding to the south of the track. The complete 20m contour appears at 1:90,000. See Figure 4. [Encl 41, 42, 43]

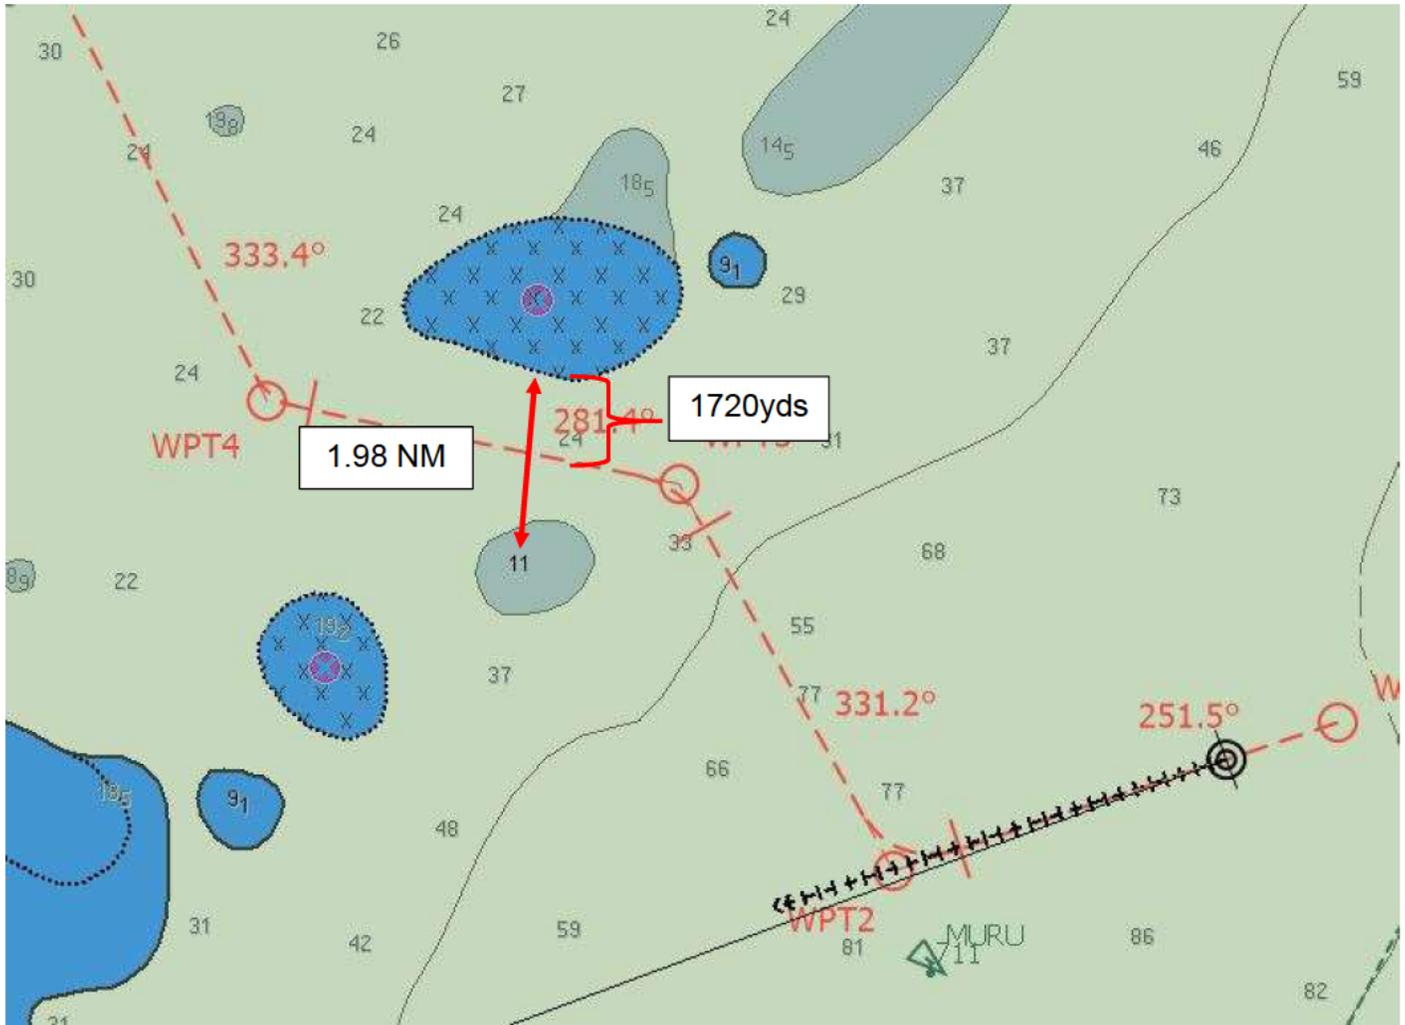
- 123. The Captain stated (b) (6) perceived the distance between the 11m sounding and shoal that laid to the north was about 5 nm wide and (b) (6) felt comfortable with that route. [Encl 2]
- 124. The measured distance between 11m sounding and shoal, the “gap” the Captain refers to is approx. 2nm. See Figure 6. [Encl 42]

Figure 6 – ECDIS 5 Duqm A Rev 2

- 125. The measured distance between planned Duqm A track and San Carlos Banks shoal to north was 0.86nm/1720yds. This distance was never discussed as a risk factor, but is well inside MSC defined restricted waters. [Ref b, d, Encl 2,4,5,6,41,42,43,48]
- 126. The Navigator stated that based on ECDIS and chart data, 24m of safe water was available throughout the proposed route. [Encl 4]

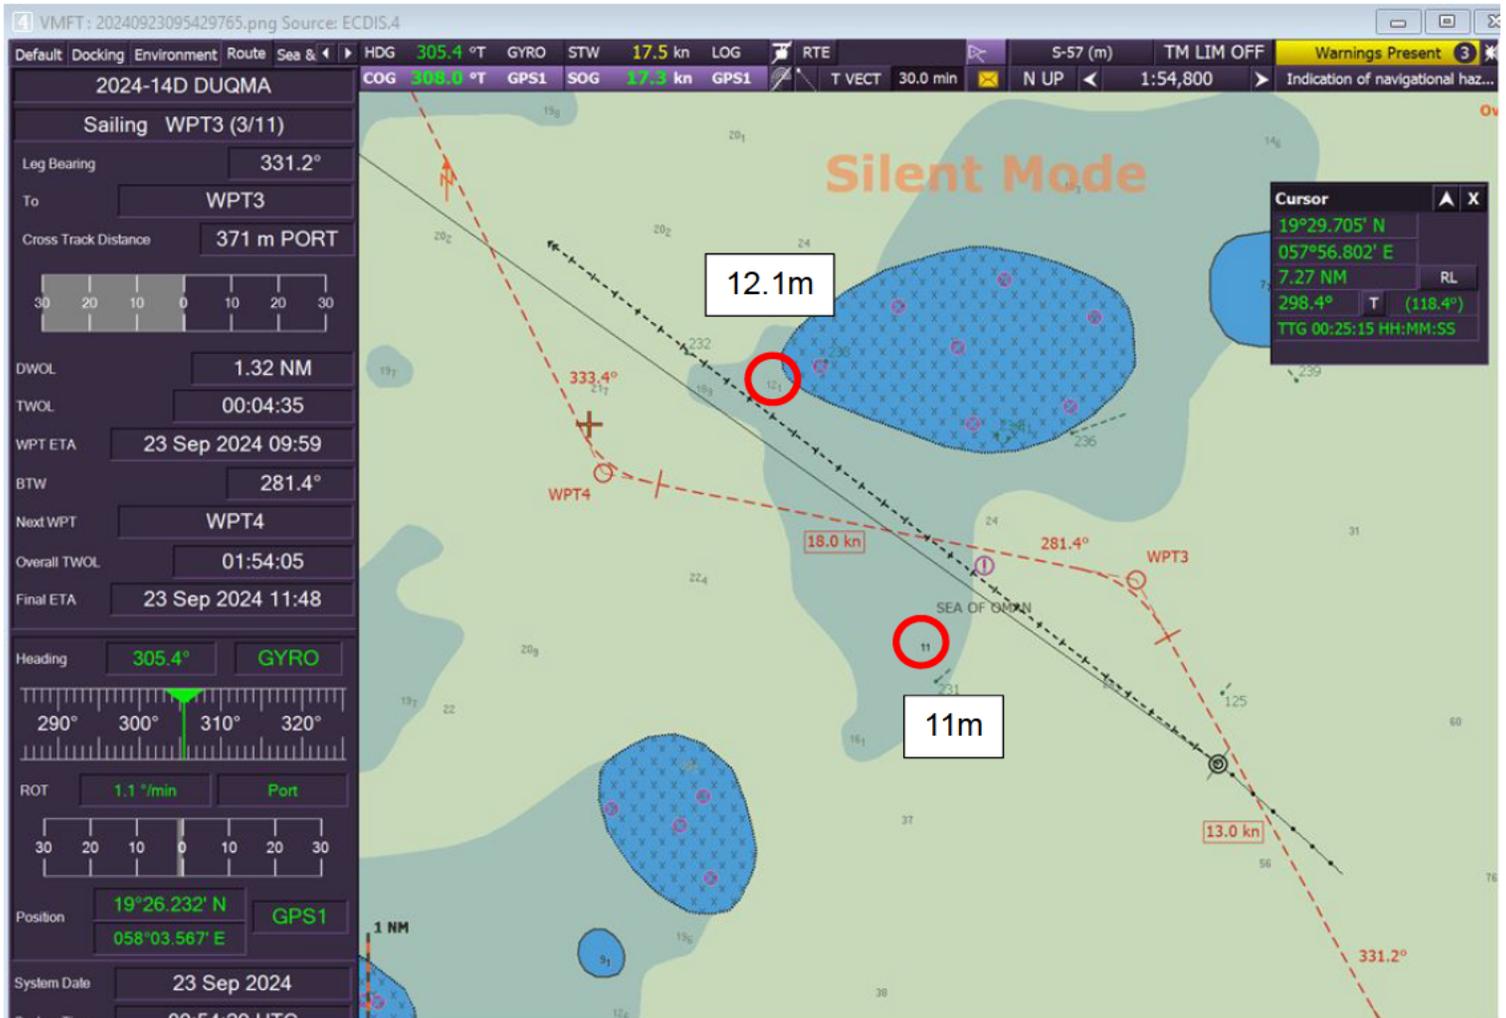
127. The Captain stated (b)(6) assumed there was 24m of water along the entire track because that is what the Navigator told (b)(6) [Encl 2]
128. ECDIS chart, at scale 1:90,000 and closer, clearly indicates the track crosses the 20m contour. See Figure 7. [Encl 41, 42, 43]

- 153. Captain stated that the speed to the pilot pick up was not an overriding factor. [Encl 2]
- 154. USCG COLREGs Rule 6, Safe Speed, states the draft of a vessel in relation to available depth of water as one of the factors of determining safe speed. [Ref k]
- 155. At 1353L, the Captain changed course to 306T. Base course remained 331T. On this course, BGN would eventually CPA shoal water to the northwest at approx. 1,000 yds. [Encl 41, 43]
- 156. At 1354L, ECDIS 4 was zoomed in to 1:54,800 scale. 20m contour and 11m sounding were clearly visible. Unclear from VDR and interviews who changed the scale on this ECDIS. It is unclear who performed this scale shift. See Figure 7. [Encl 41, 43]

Figure 7 - ECDIS 4 1354L, 20m Contour Visible

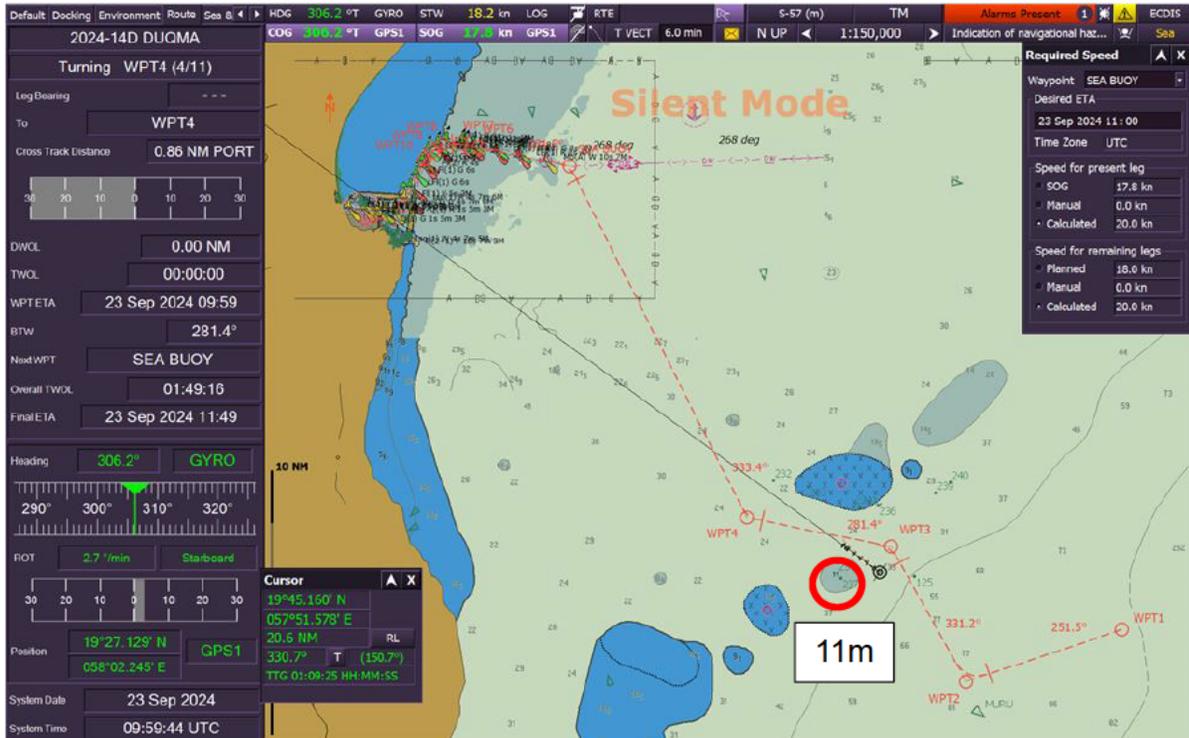
158. At 1400L, ship was steering 306T, base course was 331T, ship was going 17.7kts SOG, fathometer read 24.5m. Ship was 1,780yds left of planned track and opening. ECDIS 5 (Captain viewing) was scaled to 1:150,000 and 20m contour was not visible. ECDIS 4 was scaled to 1:54,000 and the 20m contour was visible. See Figures 8 and 9. [Encl 41, 42, 43]

Figure 8 - ECDIS 5 view at 1400L. This is the Captain's ECDIS view.

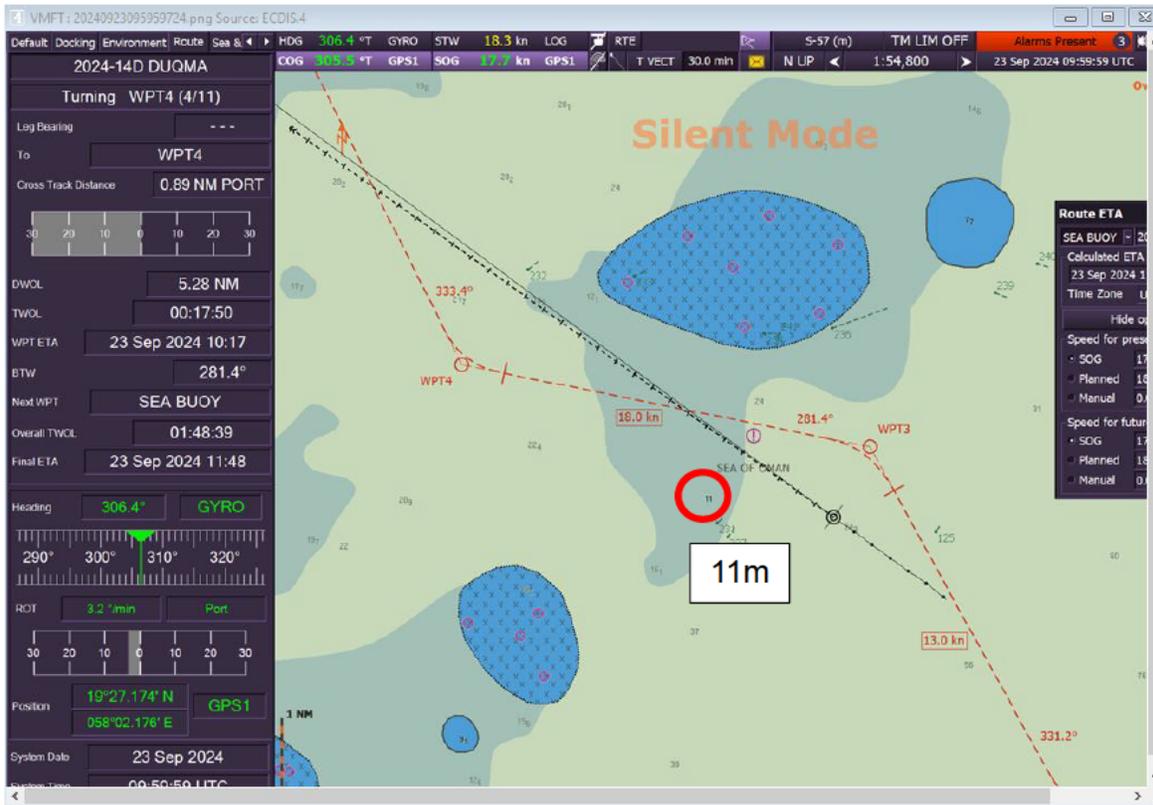
Figure 8 - ECDIS 4 Screenshot at 1400L, (grounding -12 minutes)

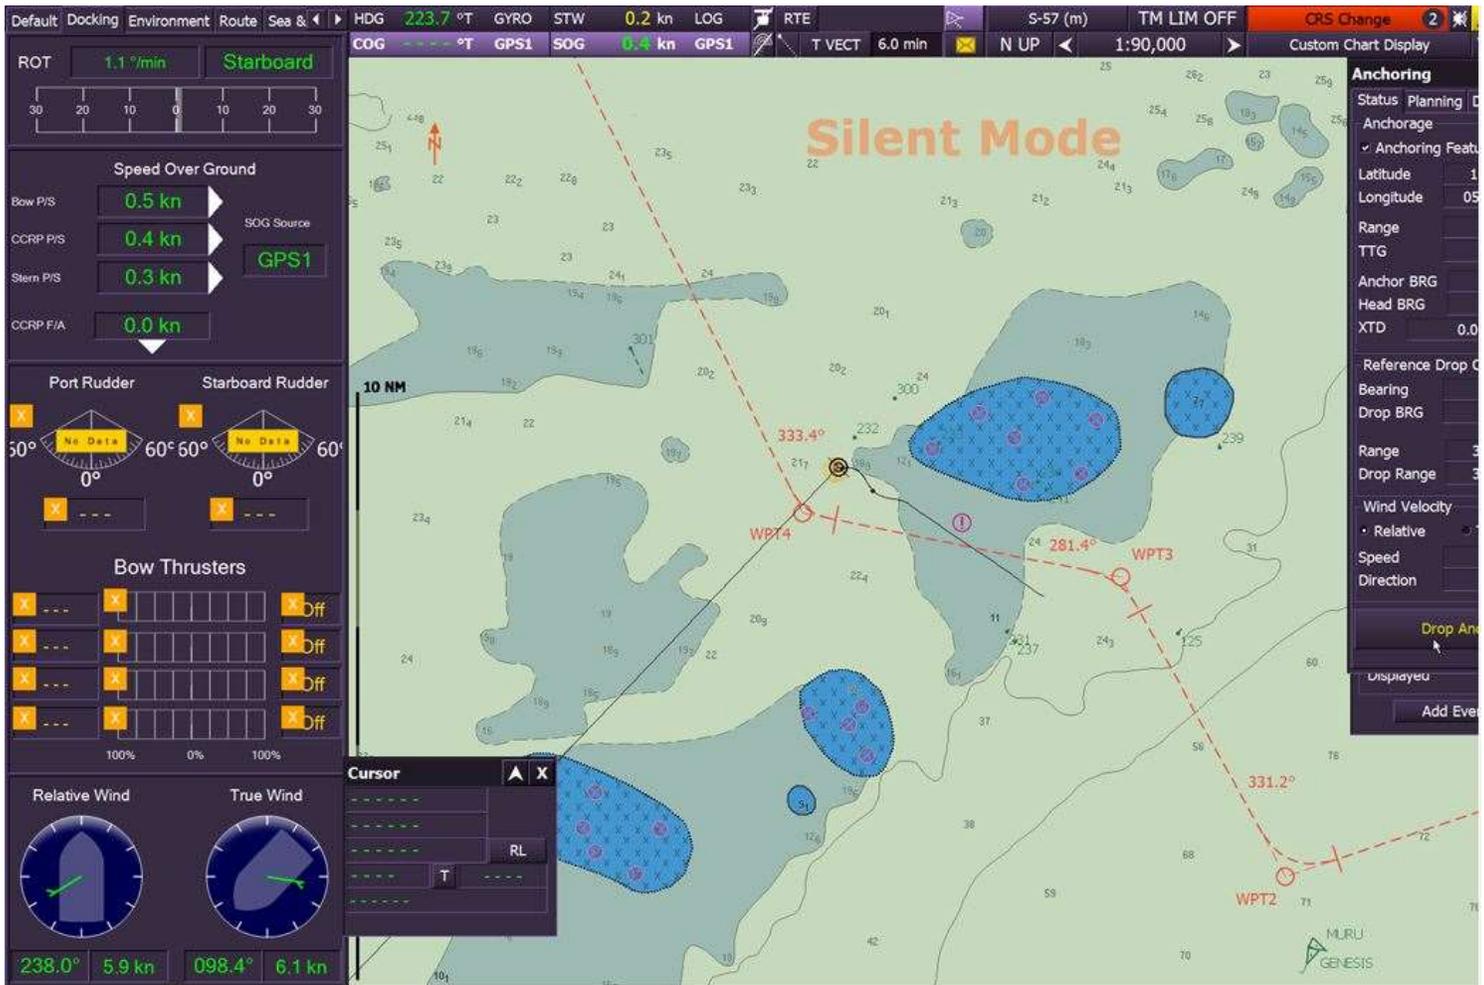
201. By 1456 the ship is safely anchored with 17.5m beneath the keel. [Encl 41, 42, 43]
202. The source of fuel in engine room was the contaminated fuel tank (a.k.a. "leak off tank") where uncombusted fuel from the main engines is collected. The fuel was pushed back up and out through the various drain lines feeding the tank. It was assumed (and later confirmed) the tank was open to and pressurized by the sea. [Encl 2, 3, 8, 12, 13]

Figure 10 - 1456L, anchored position.

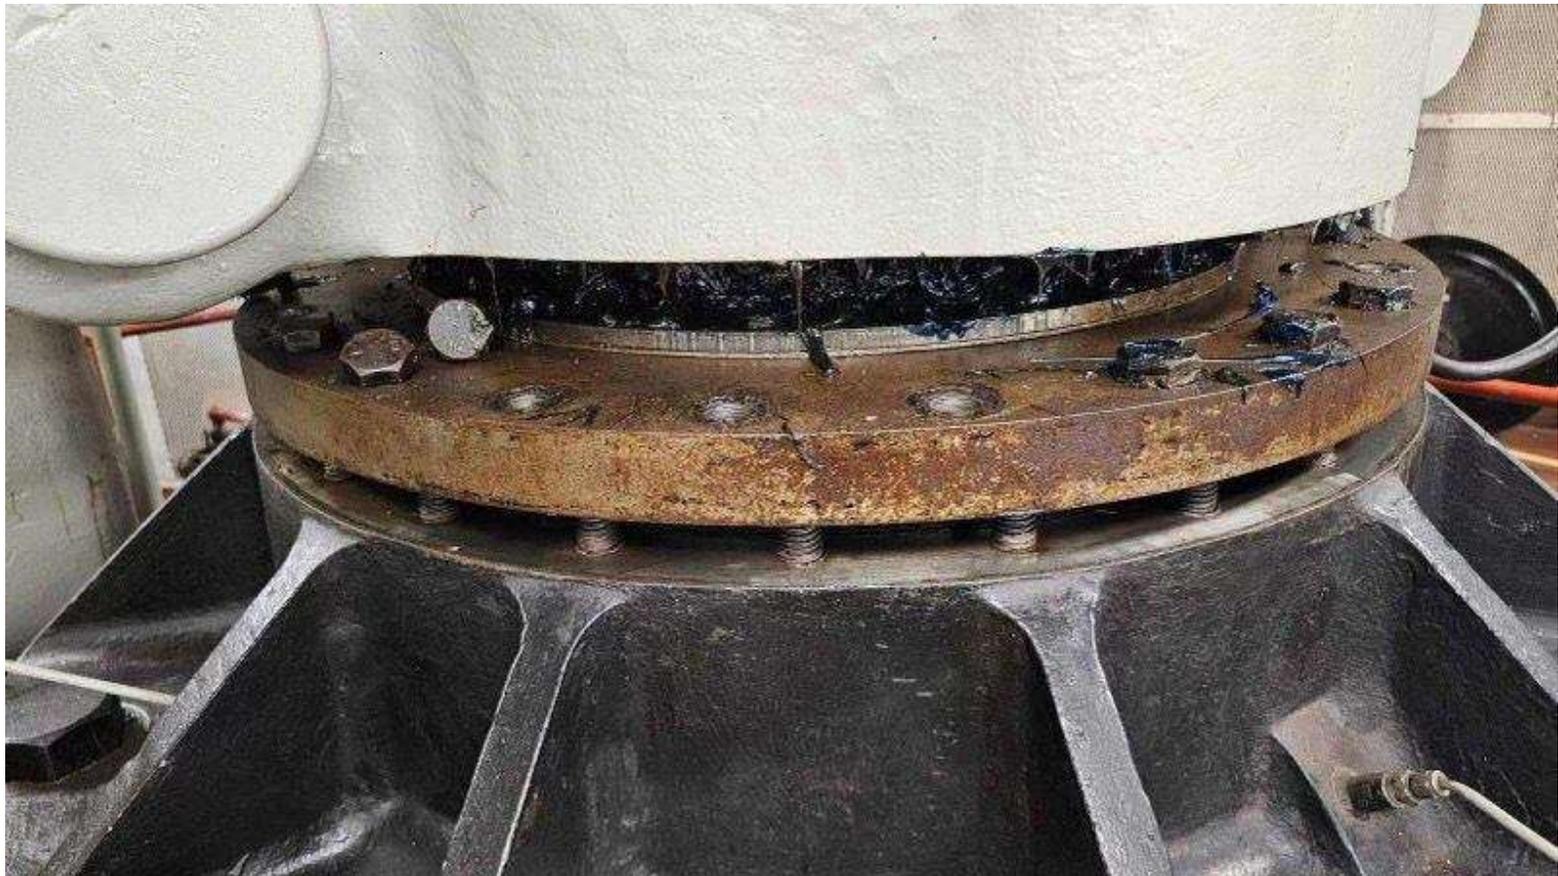
216. From CTF 56 dive report, the port rudder suffered significant damage. Multiple penetrations, metal deflection and deformities. Rudder flooded. Rudder post collar in after steering was displaced, with all bolts sheared. [Encl 40]

# Port Rudder Post Collar – Bolts Sheared / Collar Misaligned

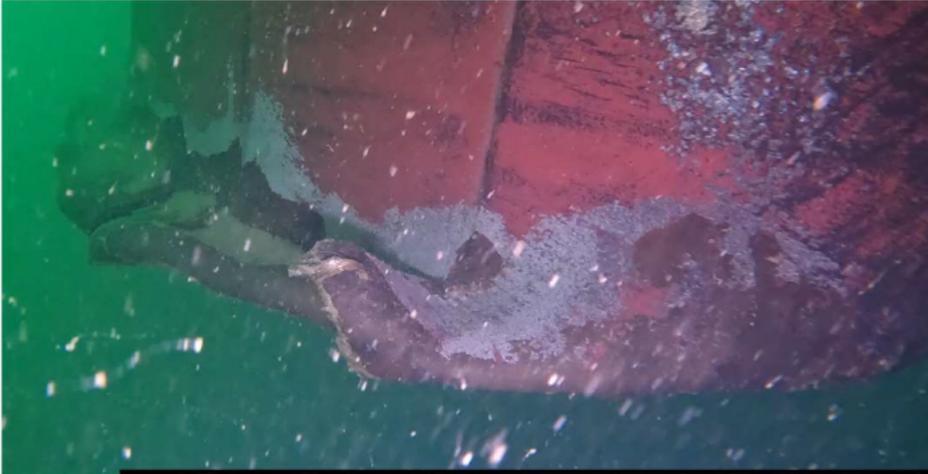
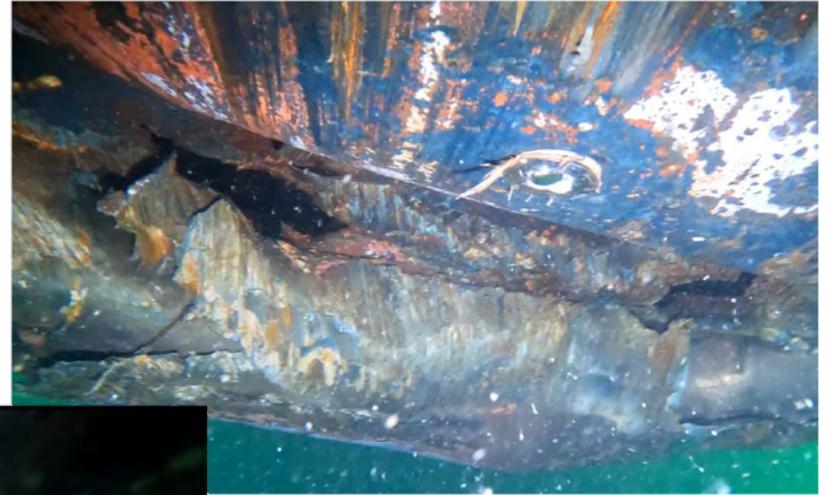
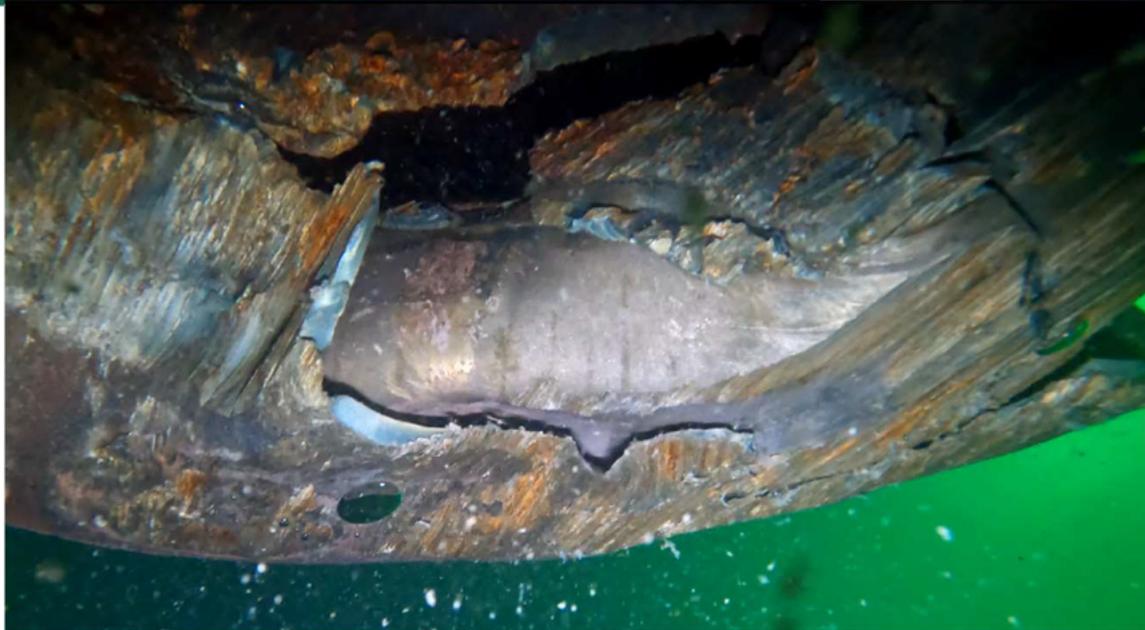
# Port Rudder<sup>CUI</sup>

Facing Aft, Vertical/Bottom Interface

Bottom of rudder

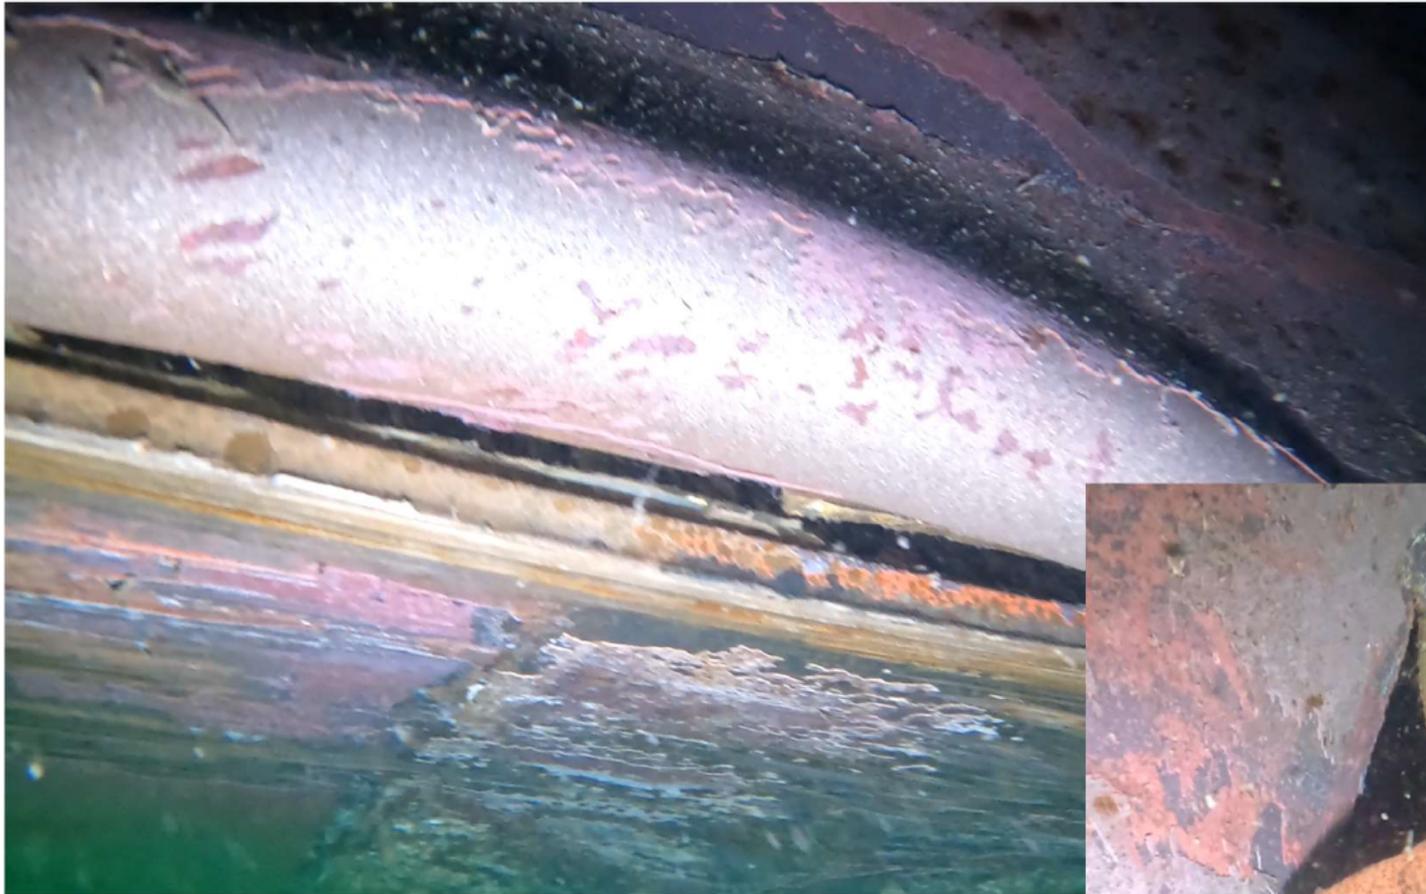
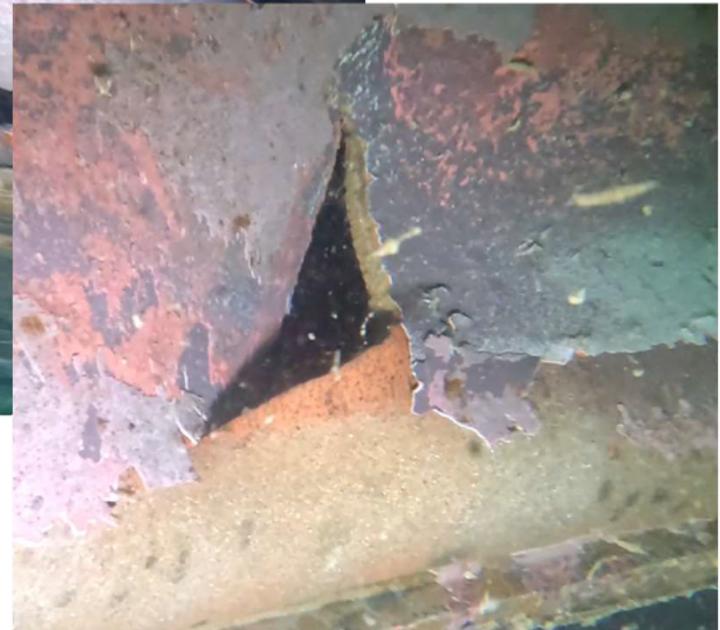
# Skeg

221. From CTF 56 dive report, significant damage was observed to the hull starting at frame 34 through stern. Multiple hull penetrations, dents, cracks, warping, and hull deflection noted from frame 34 to skeg on port side. Damage to include dents and metal deflection also present on starboard side of keel, frames 50-54. Hull cracks are all narrow (up to approx. 3" wide) and range in length from 4-5" up to approx. 16'. [Encl 40]

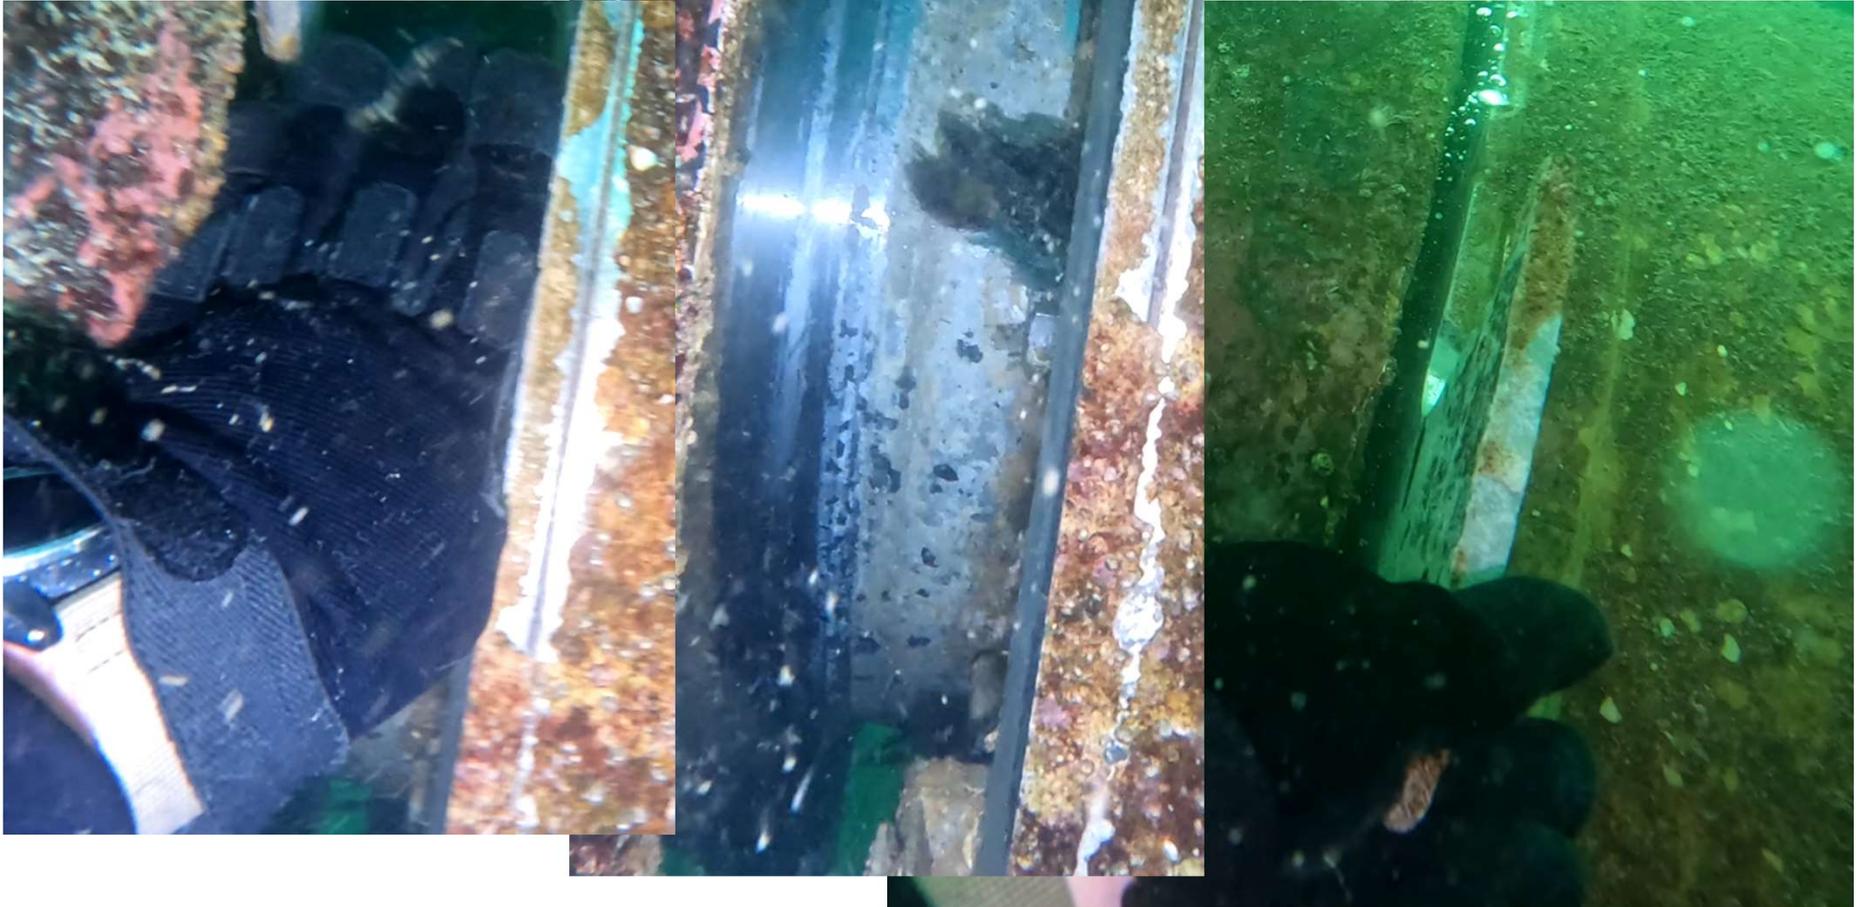
219. CTF 56 divers reported heavy hydraulic oil in the water pierside Duqm while performing initial dives. [Encl 40]
220. CTF 56 divers noted the gap between the port hub and port strut barrel to be approx. 5-6". Stbd gap is approx. 1.5". [Encl 40]

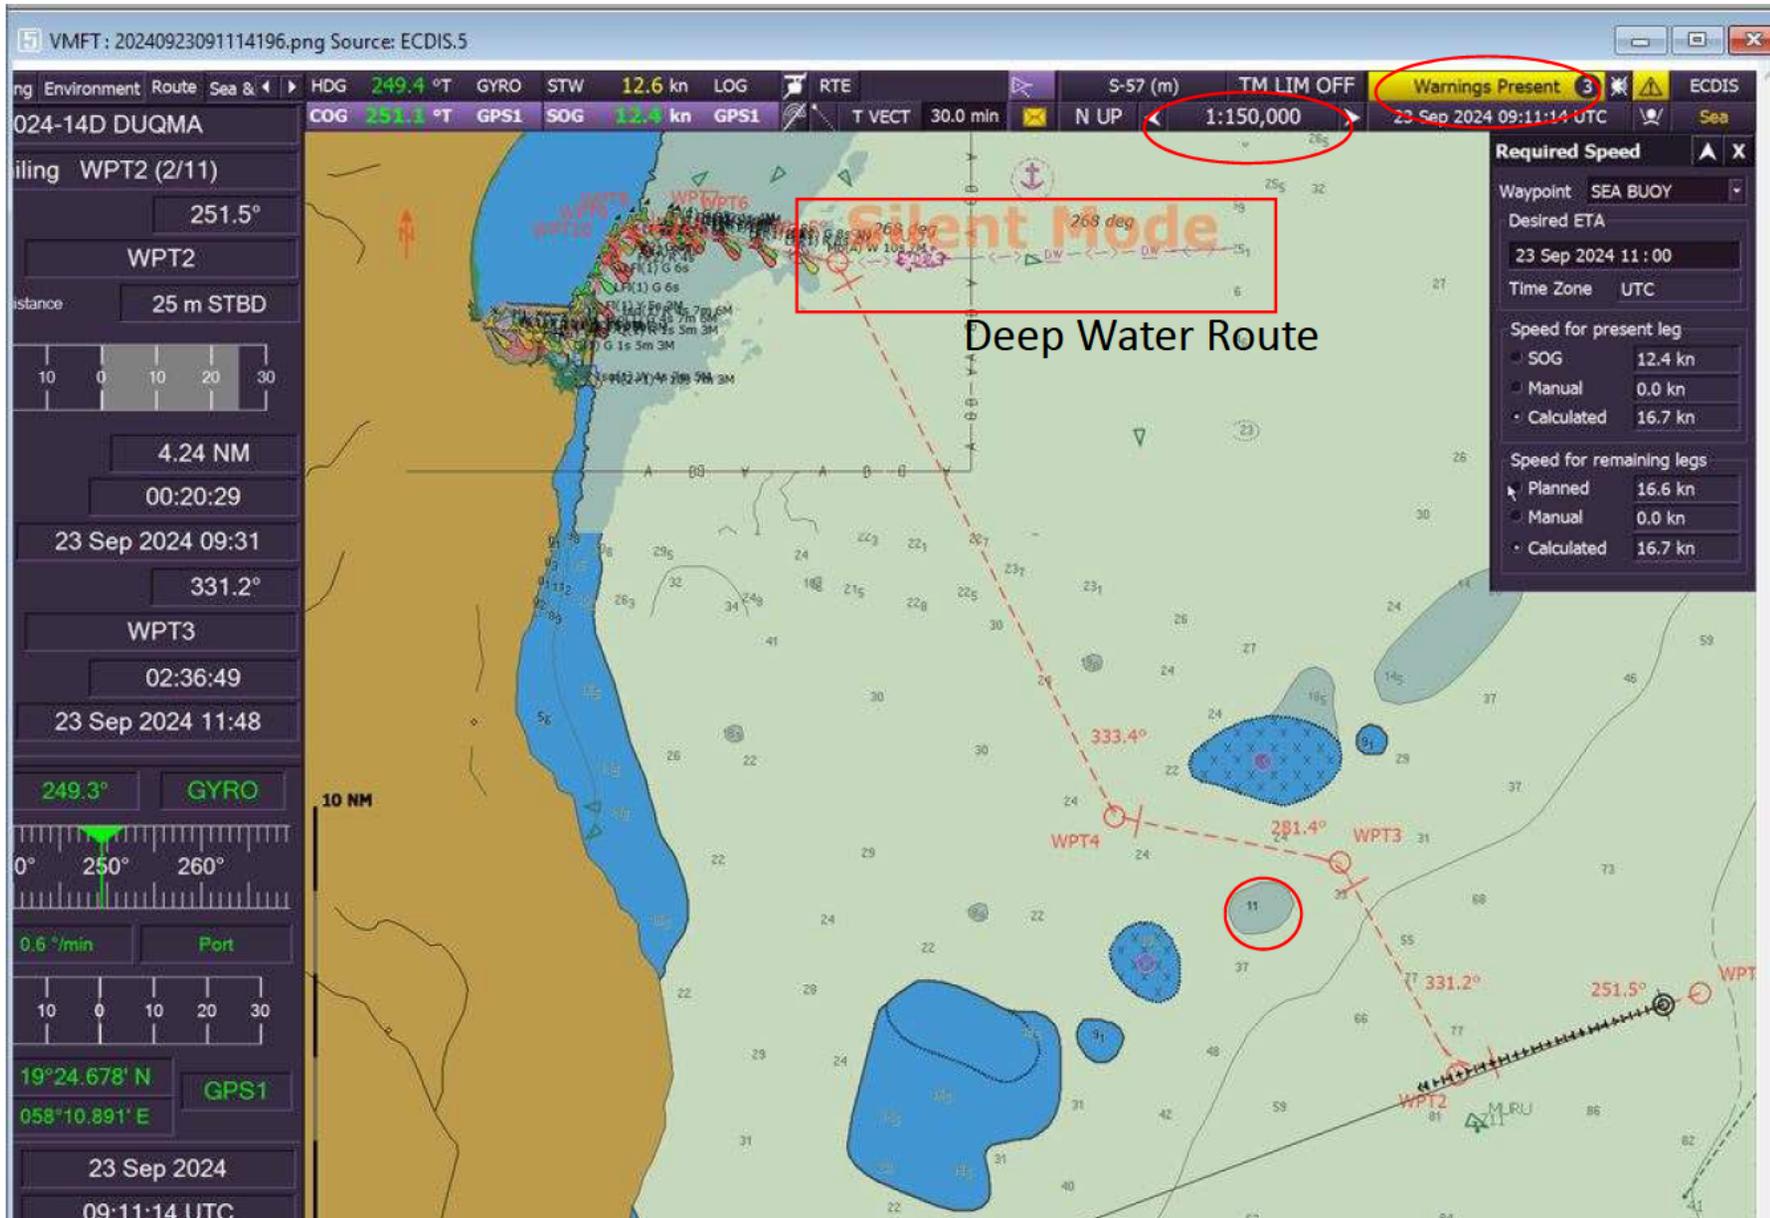
# 1311L – Duqm A Rev 2

121. By 1311L, Duqm A revision 2 was established on ECDIS 5. Planning occurred using 1:150,000 scale where the full 20m contour is not visible. The Captain and Navigator referred to it as the “shoot the gap” track during interviews. The gap referred is between a set of charted shoal water depths to the north and south. Note how the 24m soundings line up per Captain’s direction to the Navigator during their conversation. See Figure 6. [Encl 2, 4, 5, 6, 41, 42, 43]
122. The Navigator stated (b)(6) was aware of the direction in Pub 172, Sailing Directions and recommendations on charts to use the deep water route, but assessed the conditions along Duqm A to meet safety requirements. [Encl 4]
