DEPARTMENT OF THE NAVY  
MILITARY SEALIFT COMMAND  
471 EAST C STREET  
NORFOLK VA 23511-2419

FINAL ENDORSEMENT on CAPT (b)(6) ltr 5800 of 20 Nov 24

Subj: COMMAND INVESTIGATION INTO THE FACTS AND CIRCUMSTANCES  
SURROUNDING THE GROUNDING OF USNS BIG HORN (T-AO 198) OFF THE  
COAST OF OMAN ON 23 SEPTEMBER

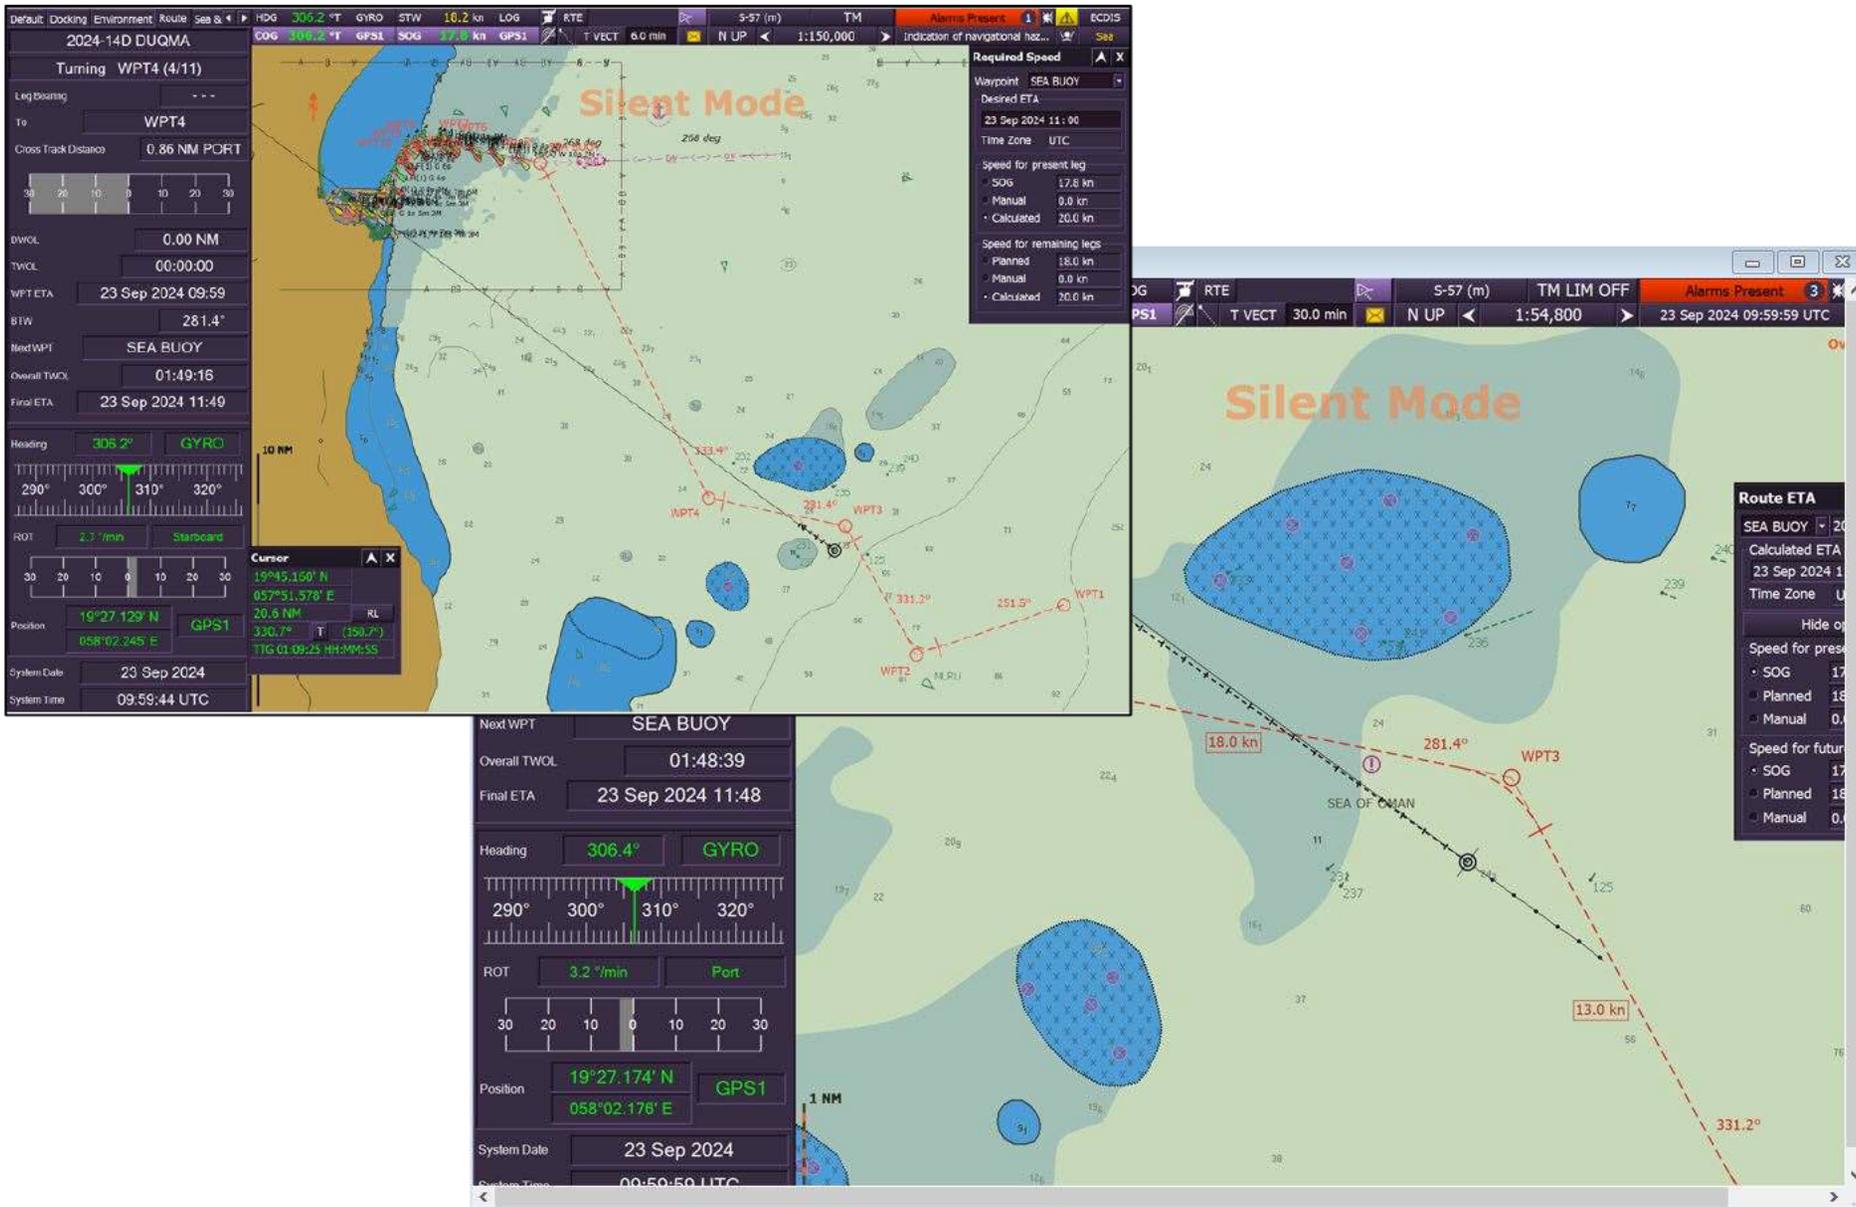
# 1400L ECDIS 5 (top) ECDIS 4 (bottom)

158. At 1400L, ship was steering 306T, base course was 331T, ship was going 17.7kts SOG, fathometer read 24.5m. Ship was 1,780yds left of planned track and opening. ECDIS 5 (Captain viewing) was scaled to 1:150,000 and 20m contour was not visible. ECDIS 4 was scaled to 1:54,000 and the 20m contour was visible. See Figures 8 and 9. [Encl 41, 42, 43]

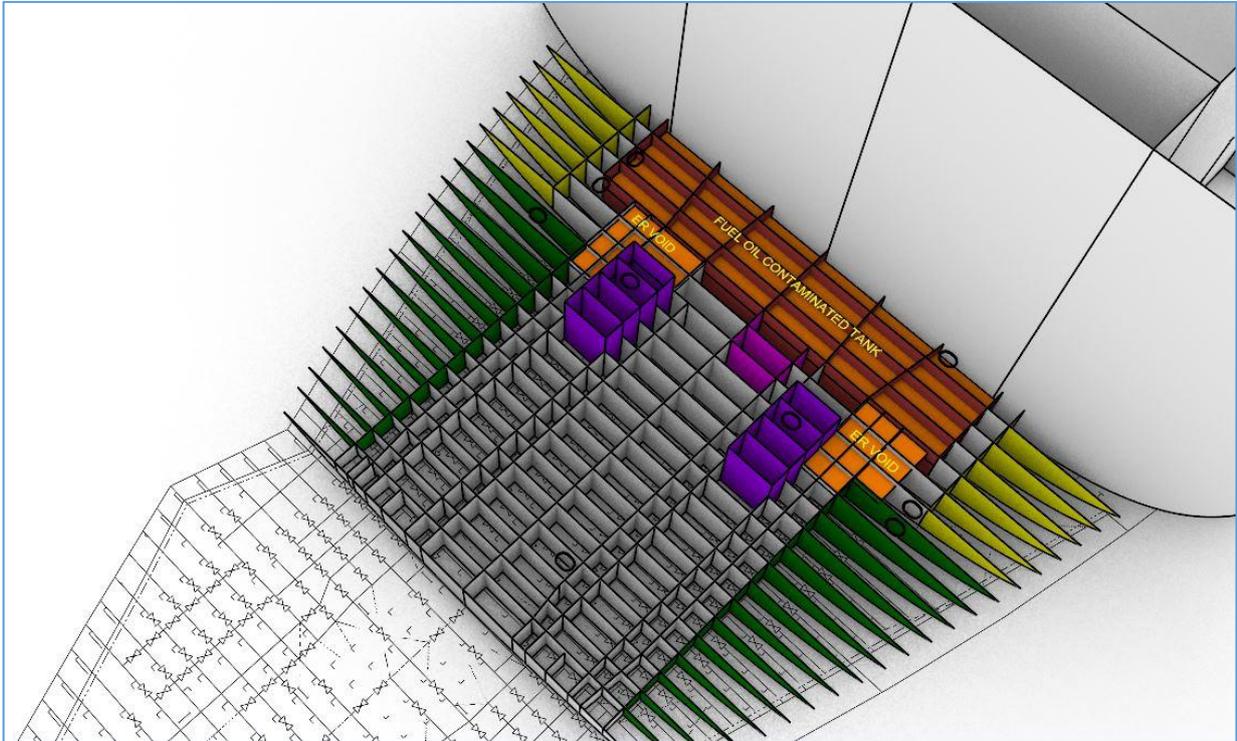
The below images illustrate the areas that are presumed to require sealing by welding or grout patching. The areas where patching is expected to be required are indicated in orange color. Until water ingress is fully stopped by divers, areas pumped dry and made gas free, the planning and patching locations is based on numerous assumptions and is subject to change.

Figure 1 - Illustrates patching required in FO Contamination Tank and Engine Room Void in orange

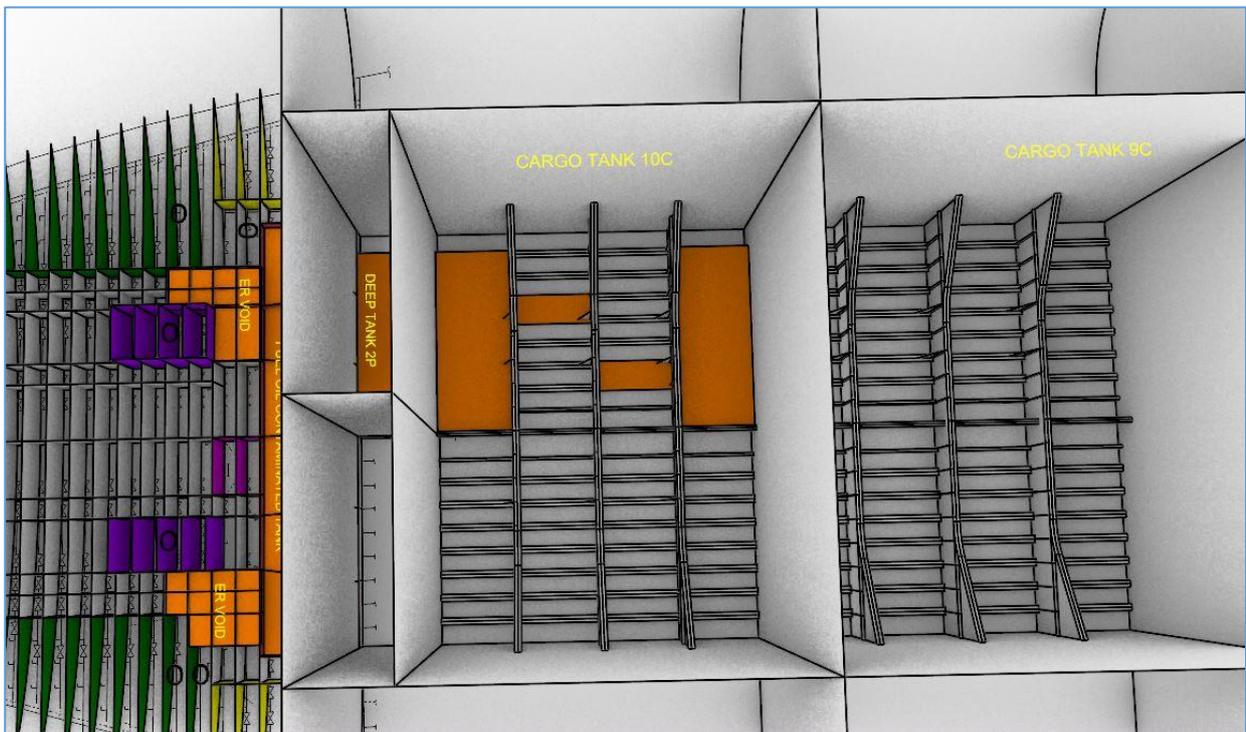
Figure 2 - Illustrates patching required in Cargo Tank #10C and #2 Deep Fuel Oil Tank in orange

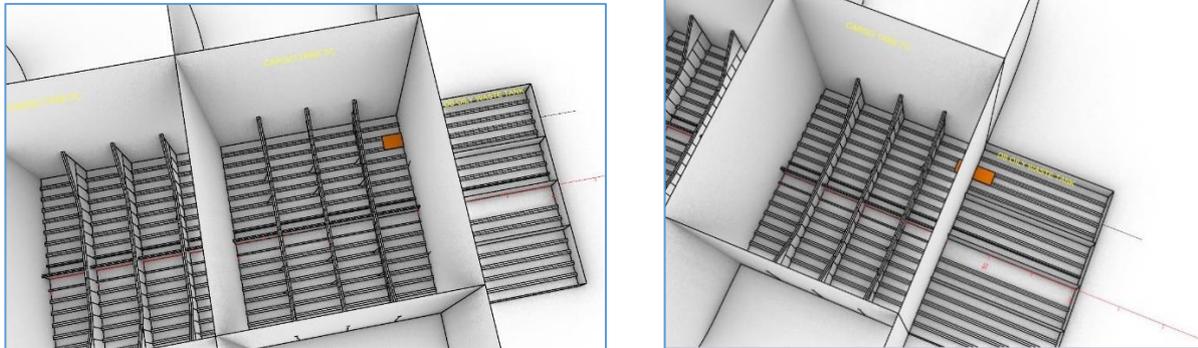
Figure 3 Illustrates patching required in cargo tank #7C and DB Oily Waste Tank at bulkhead in orange

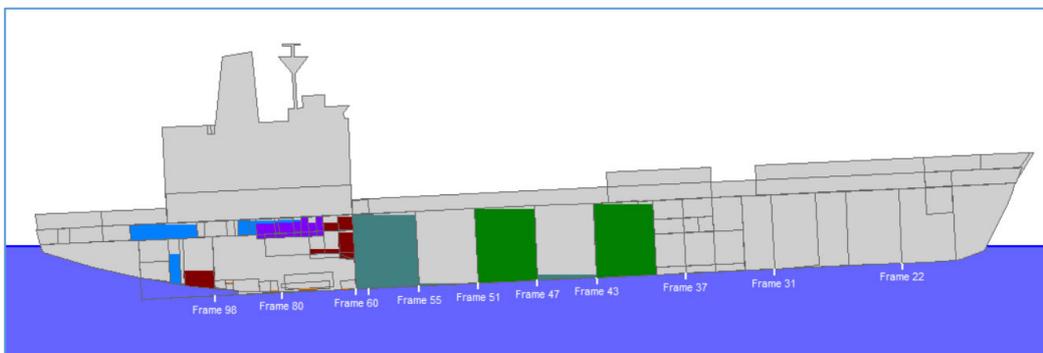
Furthermore, this loading condition shows that even without structural reinforcements the occurring Bending Moments/Shear Forces at-sea can be reduced to be less than the damaged allowable Bending Moments/Shear Forces.

Figure 4 - USNS BIG HORN Loading Condition where Bending Moments are kept at a minimum

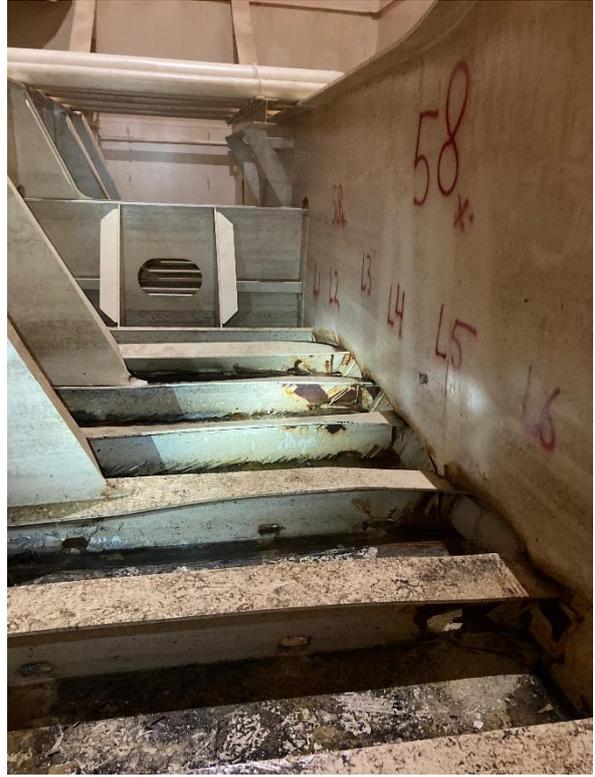
Figure 2 - PS CT 10C Frame 58 looking aft

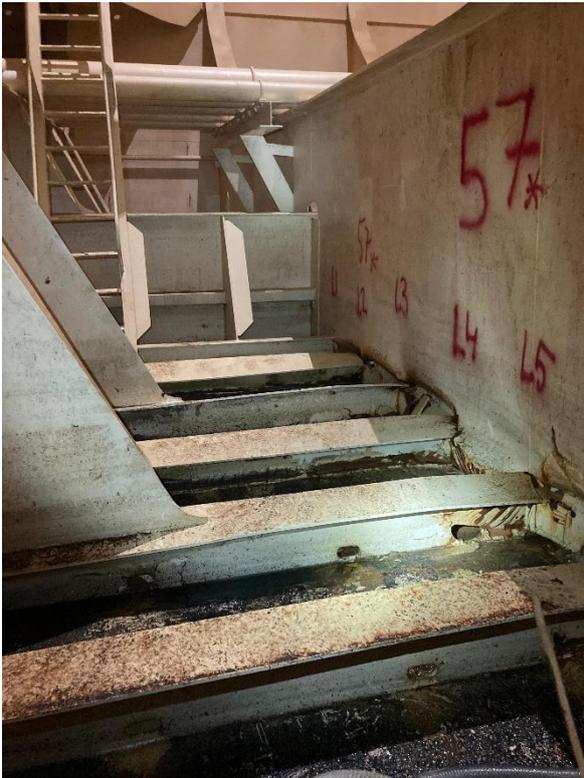
Figure 3 - PS CT 10C Frame 57 looking aft

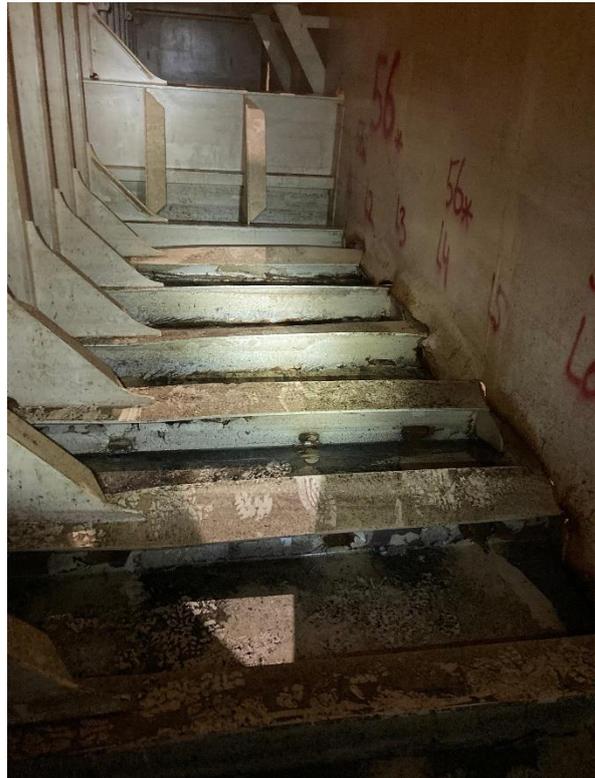
Figure 4 - PS CT 10C Frame 56 looking aft

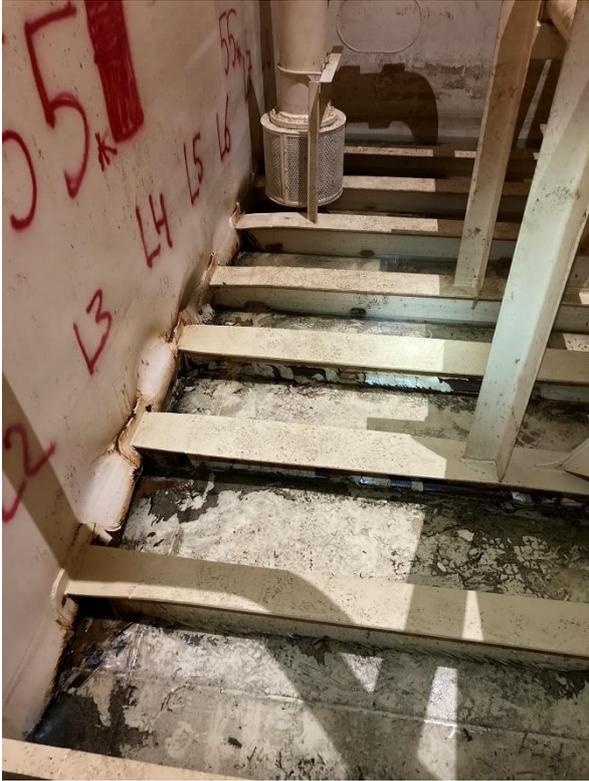
Figure 5 - PS CT 9C Frame 55 looking aft

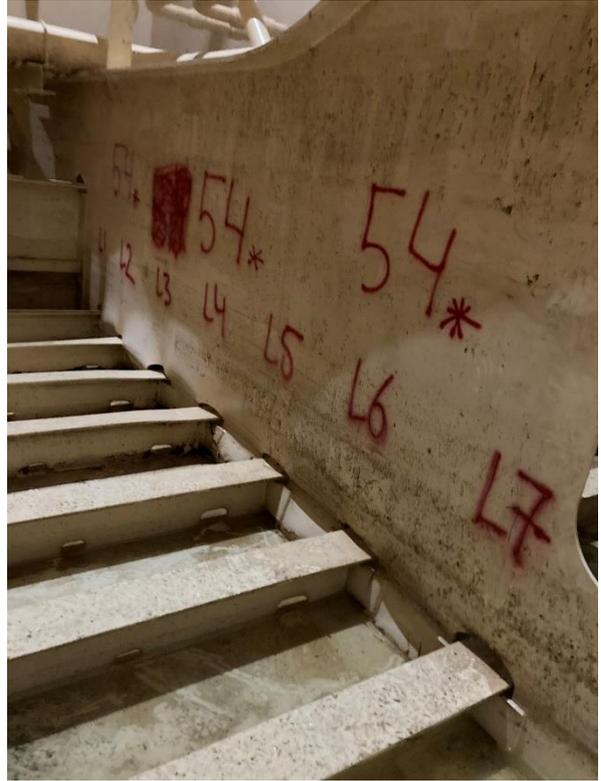
Figure 6 - PS CT 9C Frame 54 looking aft

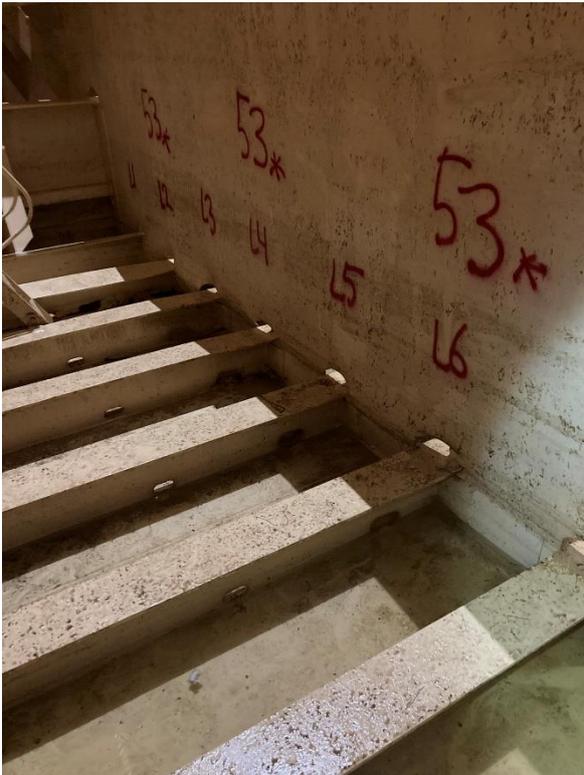
Figure 7 - PS CT 9C Frame 53 looking aft

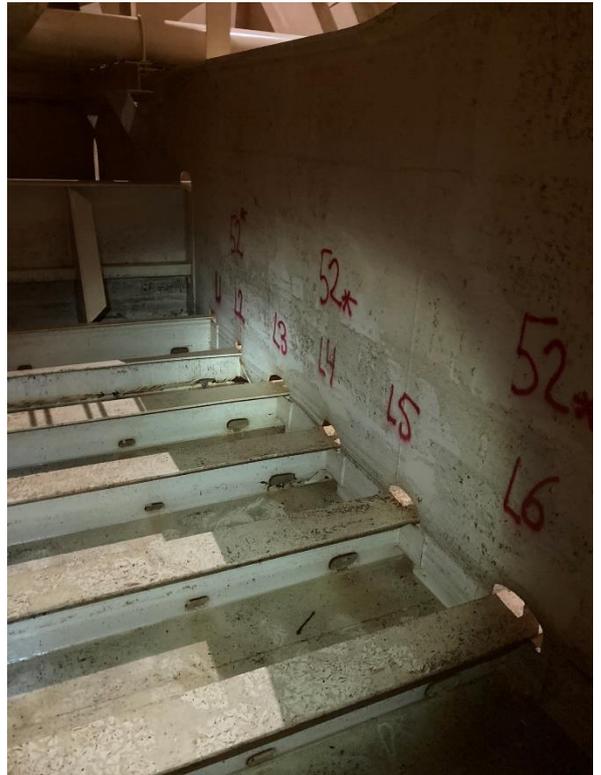
Figure 8 - PS CT 9C Frame 52 looking aft

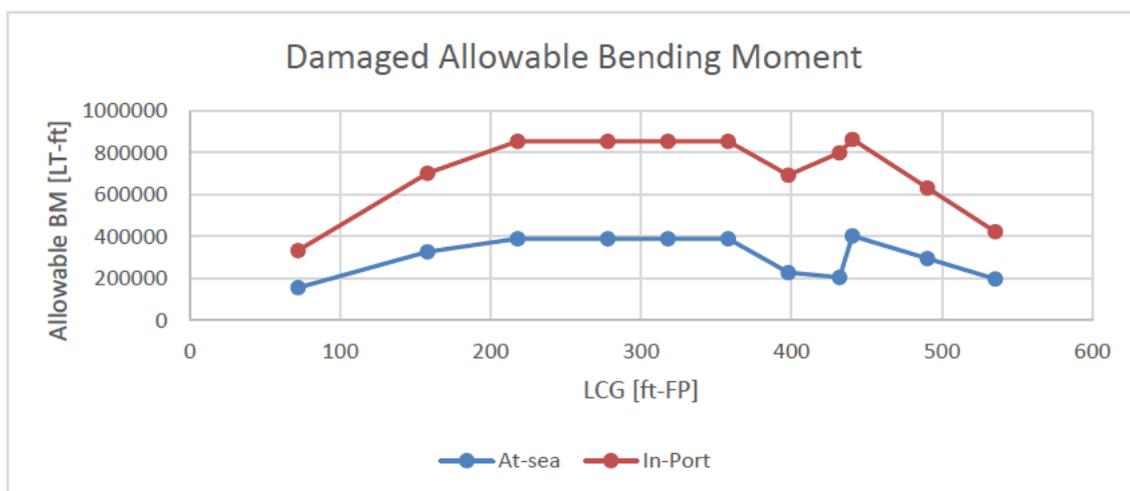
Figure 15 - Damaged Allowable Bending Moment for In-Port and At-sea

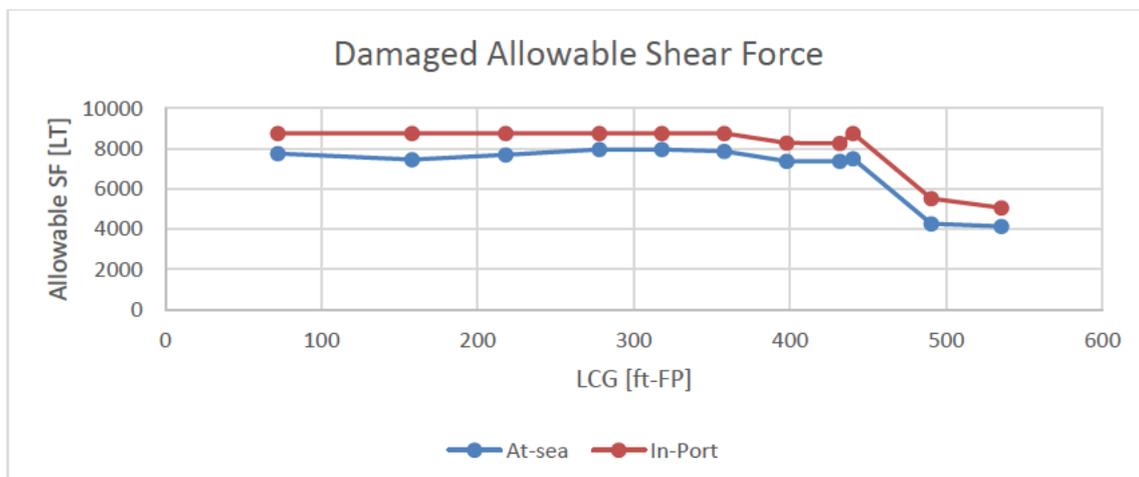
Figure 16 - Damaged Allowable Shear Force for In-Port and At-sea

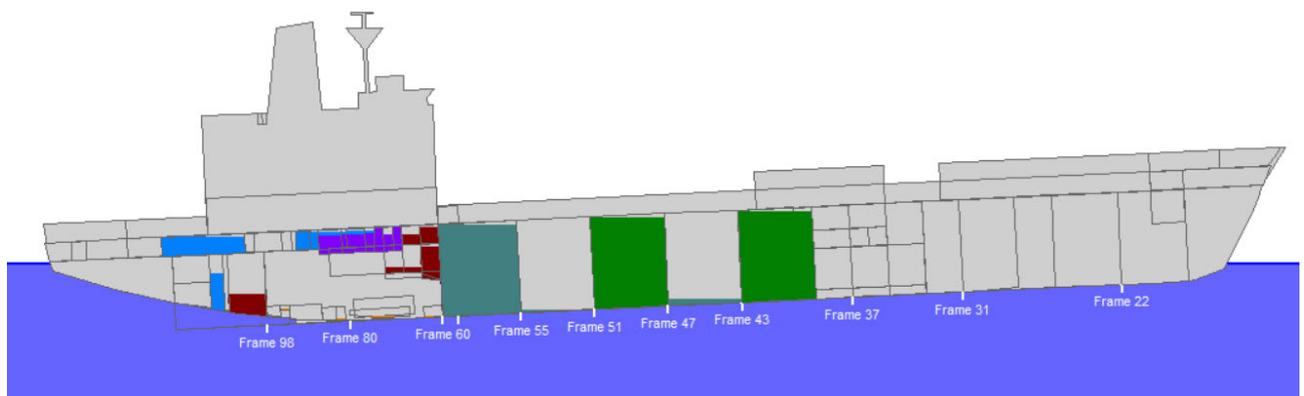
The ballast tanks which are situated most aft (8P, 8S, 6P, 6S) are used to reduce the Bending Moment aft of Frame 51. The bending moment could be further reduced if the most aft intact tanks (CT 10P and CT 10S) were used. It should however be noted that these tanks currently contain DFM and should be discharged to avoid any potential oil spill if anything were to happen. CT 10P and CT 10S should then be thoroughly cleaned to ensure that ballast water can be taken in without risk of contamination, allowing for its normal discharge in the future.

**Figure 17 - USNS BIG HORN with optimal loading condition for minimum Bending Moments aft of Frame 51**

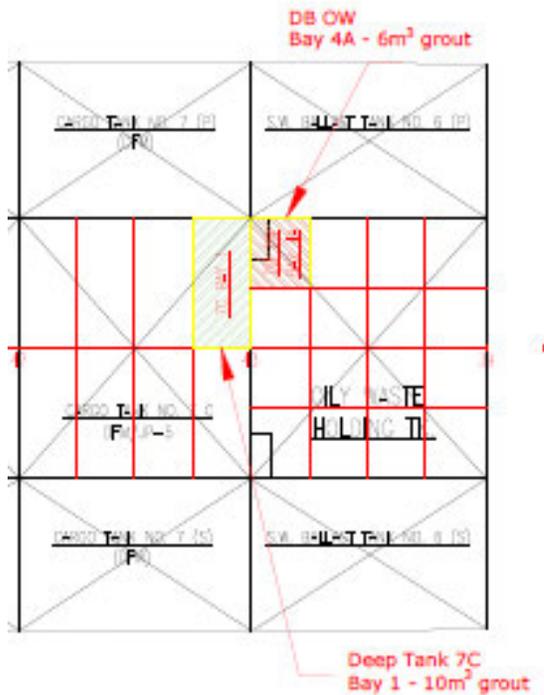
Midship Grout Locations

2. Hull penetrations leading to water ingress were limited to the Engine Room Void, Main Contaminated Fuel Tank, Deep Tank 2P, Cargo Tank 10C, and the Pump Room Double Bottom Oily Waste Tank. Progressive flooding through damaged bulkheads resulted in additional ingress into Cargo Oil

3. The grout proposed and locally available is a mixture of OPC Cement, GGBS, Microsilica, and Water with additives for waterproofing, non-shrink, and improved liquidity. Manufacturer testing confirmed a minimum compressive strength of 50 MPa and tensile strength of 15 MPa. Testing for Young's Modulus (elasticity) is not commonly performed but is being pursued for this specific mixture. A review of literature from previous testing has determined that elasticity is directly proportional to the size of the aggregate. Testing performed on a sample with an aggregate of gravel and quartz sand produced a Young's Modulus of 1550 MPa. This property was used for the analysis as the proposed grout has a smaller aggregate and is anticipated to have a lower Young's Modulus, the assessment will be updated if testing of the specific grout is attainable.

4. As the BIG HORN is structurally sound for tow the grout is not required to increase structural capacity but only to provide an internal patch to stop water ingress at crack locations and across compromised bulkheads. Once applied to a sufficient height to withstand the external

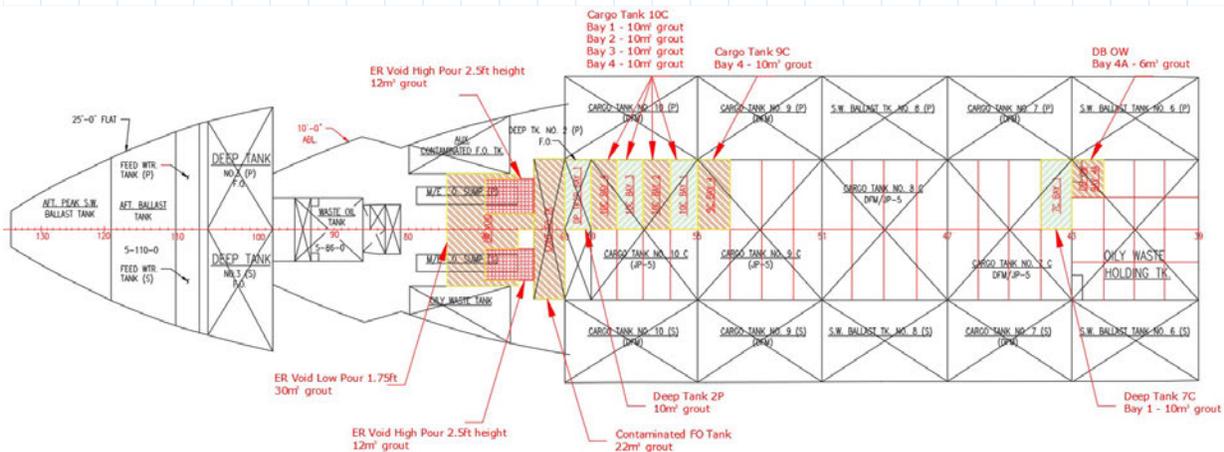
Based on observed deformations and hull penetrations, a grout plan was developed to internally seal the hull penetrations. This plan incorporates compartmentalization to facilitate grout application and ensure adequate pour height in each section.

The areas or bays designated for grouting are divided into compartments. In Cargo Tanks 10C, 9C, 7C, and the DB OWT, compartmentalization is achieved using web frames and longitudinal girders. Penetrations, such as scallop holes and longitudinal stiffener pass-throughs, are blocked off to create distinct bays. Each of these compartmentalized bays will then be grouted individually. Deep Tank 2P and the FO Contaminated Tank will each be grouted in a single lift. For the Engine Room Void, a similar approach to the Cargo Tanks will be used, with the structure compartmentalized into boxes using the ship's existing structural members.

The following figure illustrates the grouting plan:

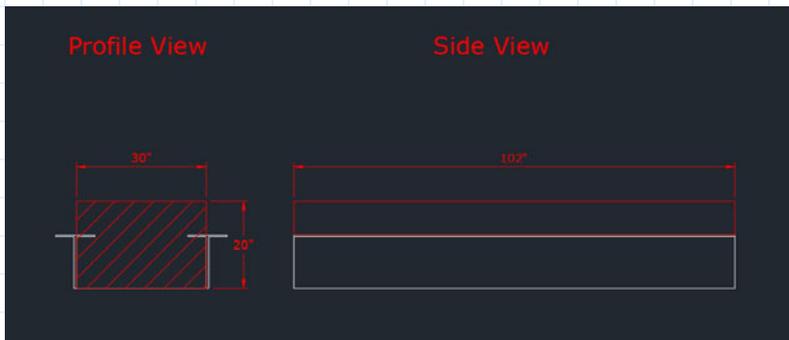
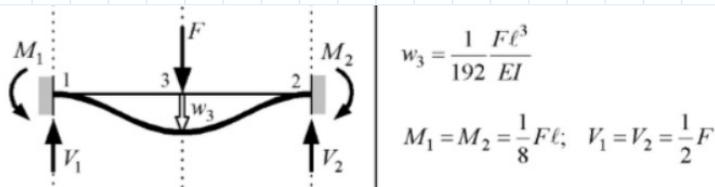
The maximum change in relative deflection for a bay in between frame 55 and frame 59 can be calculated as there are four bays:

$$w_3 := \frac{\Delta\delta_{maxBM\_LC\_59\_55} - \Delta\delta_{towing\_LC\_59\_55}}{4} = 0.085 \text{ in}$$

The problem is approximated by assuming this grout beam has two fixed supports with a force applied on the grout beam.

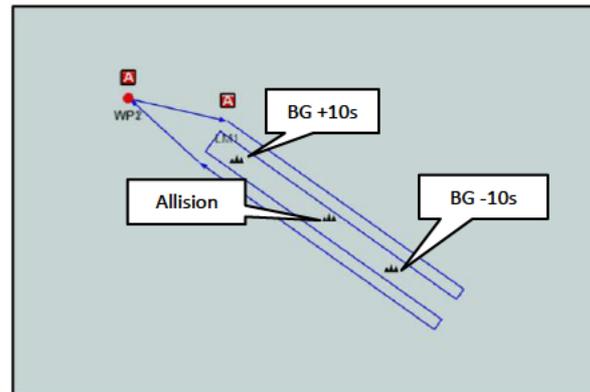
(U) Fig 1: Mk 18 Mod 1 Mission

(U) The team ran a Mk 18 Mod 1 UUV on the track displayed in Figure 1 (right). This track encompasses a roughly 100m by 300m area where the BIGHORN allision occurred. The southeastern mountain marker represents the ship position 10 seconds before allision, the middle marker is the likely allision point, and the northwestern marker is the ship position 10 seconds after allision. All positions were acquired from the track logs of the BIGHORN. Figures 2-4 (below) show sonar imaging at each location. Note the rocky bottom throughout the area. The UUV measured depths ranging from 9.4 to 12 meters through the area with an average depth between 10 and 11 meters. The BIGHORN most likely impacted the large triangular shaped rock at a depth of 10m displayed in figure 3 (below).

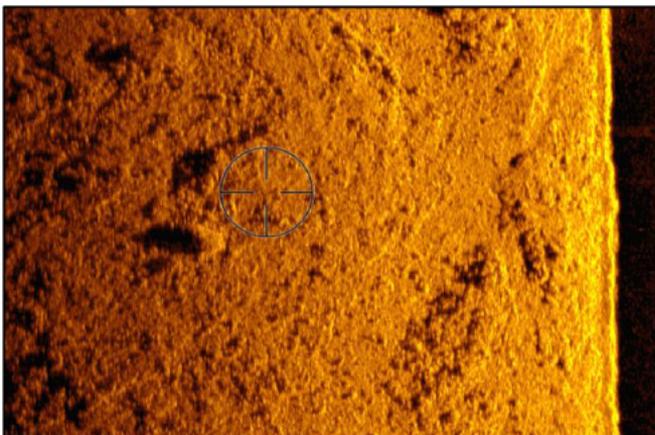
(U) Fig 2: Sonar Imagery of BG track 10 seconds before allision.

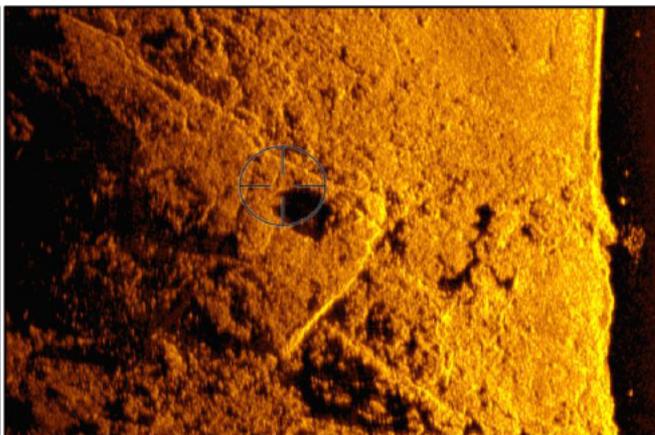
(U) Fig 3: Sonar Imagery of suspected allision point. Triangular rock depth was measured at 10 meters.

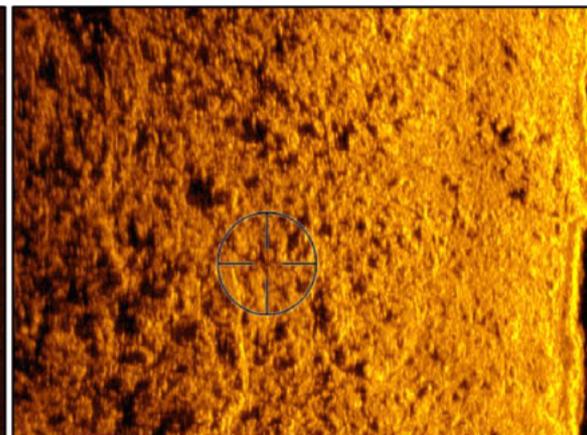
(U) Fig 4: Sonar Imagery of BG track 10 seconds after allision.

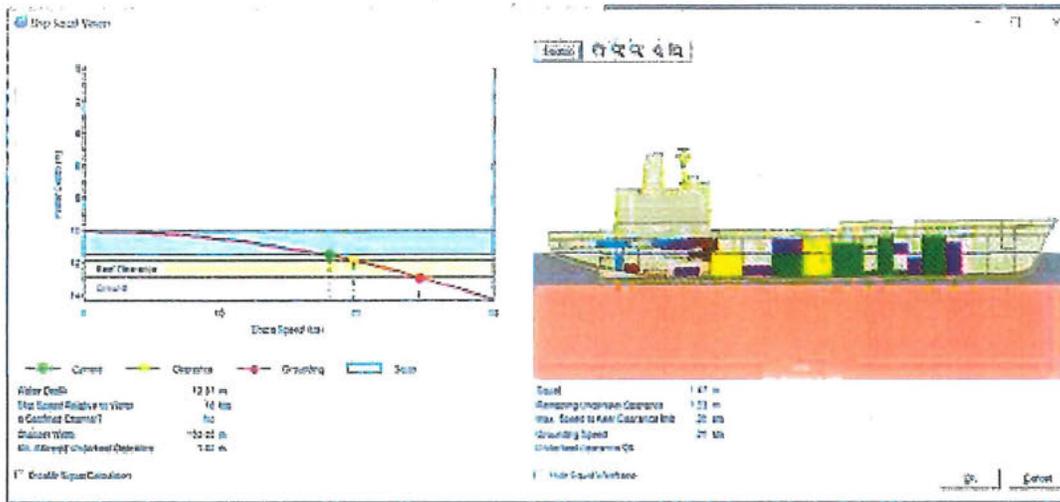
- c. CargoMax referenced methodology. Noted to be wide ranging in assumptions and is simplified.
  - d. **Calculated Squat = 1.47m**, See screen shot below.
